VENDOR SERVICE PUBLICATION

Subject: Garrett AiResearch Manufacturing Company of California
Service Bulletin No. 5-2294, Revision No. 1, dated December 15, 1980.
("Outflow/Safety Valve - Inspection for Suspected Faulty Poppet")

PA-31T Cheyenne II

OUTFLOW/SAFETY VALVE - Inspection for suspected faulty poppet

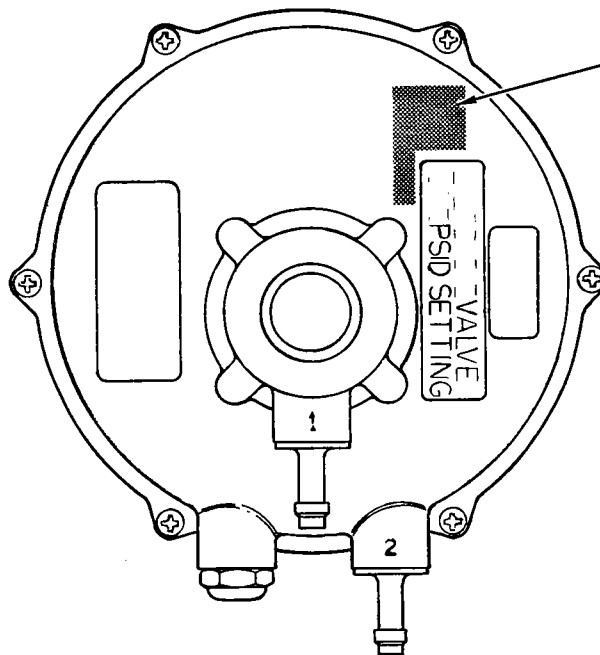
IDENTIFICATION OF F T DATE

- (1) Inspect all installed outflow/safety valves as follows:
 - (a) Visually check the functional test (FT) date appearing on cover of outflow/safety valve (see figure 1) to determine if the FT date falls between 1 January 1980 through 31 Aug. 1980. If the FT date is not within these dates and no physical damage is apparent, no further action is required and outflow/safety valve is considered serviceable.

F T INK STAMPED DATE
WILL BE IN THIS AREA.

EXAMPLE: AUG 28 1980

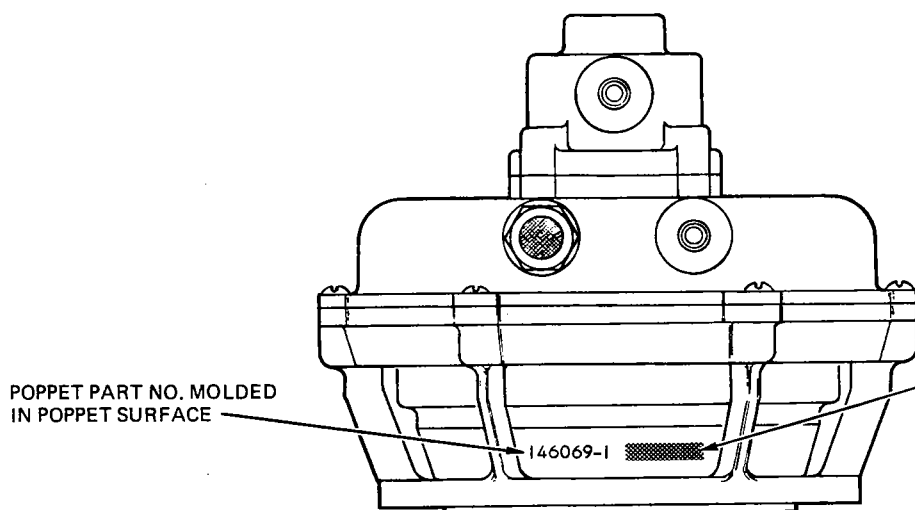
IDENTIFICATION OF POPPET DATE

The problem area is centered around the outflow valve poppet assembly. It is suspected that a small percentage of the poppet assemblies could fracture, and depending upon the type of fracture, could go as an unlisted fault or if a total fracture occurs could lead to a valve closure.

POPPET PART NO. MOLDED
IN POPPET SURFACE

INK STAMPED DATE WILL BE IN
THIS AREA NEXT TO POPPET PART
NO. OR WILL BE APPROXIMATELY
180° FROM POPPET PART NO.

EXAMPLE: APR 4 1980

- (b) If check of the FT date is between the specified date of 1 January 1980 and 31 August 1980, perform check of poppet assembly to determine if a date stamp appears on surface of poppet (figure 1), or if poppet is fractured. If poppet does not have a date stamp, remove and replace the outflow/safety valve within 100 flight hours after receipt of this bulletin. If poppet is fractured, remove and replace defective outflow/safety valve prior to next flight. Return outflow/safety valve to Piper Aircraft for replacement.
- (c) If check of poppet assembly reveals a date stamp on poppet, regardless of an FT date within 1 January 1980 through 31 Aug. 1980, the poppet assembly is considered servicable and outflow/safety valve can remain in use.
