# SERVICE BULLETIN

No. 629

Piper Aircraft Corporation

Subject: Landing Gear Hose Assembly Inspection  
and Replacement.

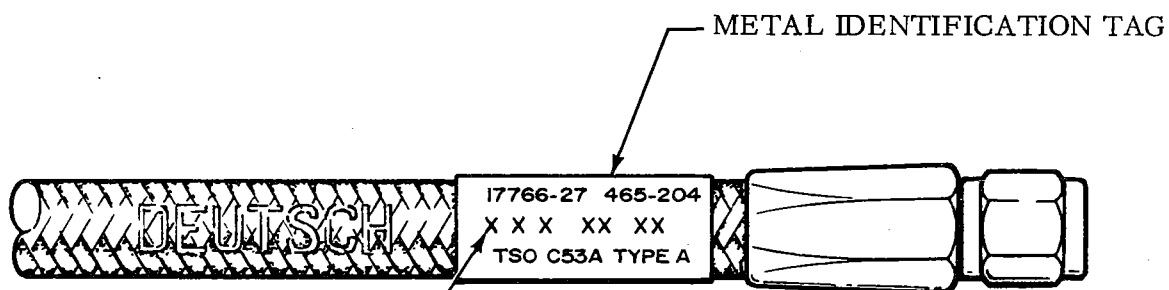
2. Inspect the metal identification tag on the Hose Assemblies for an assembly date of 4Q77 or 1Q78 (See attached sketch).
3. If a Hose Assembly has an assembly date other than 4Q77 or 1Q78, no further action is required. Make an appropriate log book entry of compliance with this Service Bulletin.

INSPECT ASSEMBLY DATE. HOSE ASSEMBLY  
WITH ASSEMBLY DATE OF 4Q77 or 1Q78  
MUST BE REPLACED.

5. Remove Hose Assembly(ies) which have assembly dates of 4Q77 or 1Q78. Visually inspect the Hose Assembly for blockage, deterioration or signs of leakage which would indicate delamination.

6. If no evidence of delamination is present, replace the Hose Assembly(ies) with new part(s) having an acceptable assembly date and proceed to steps 6.a. and 6.b.
