# SERVICE LETTER

No. 969

Piper Aircraft Corporation

Wing Tip Ground Strap Installation

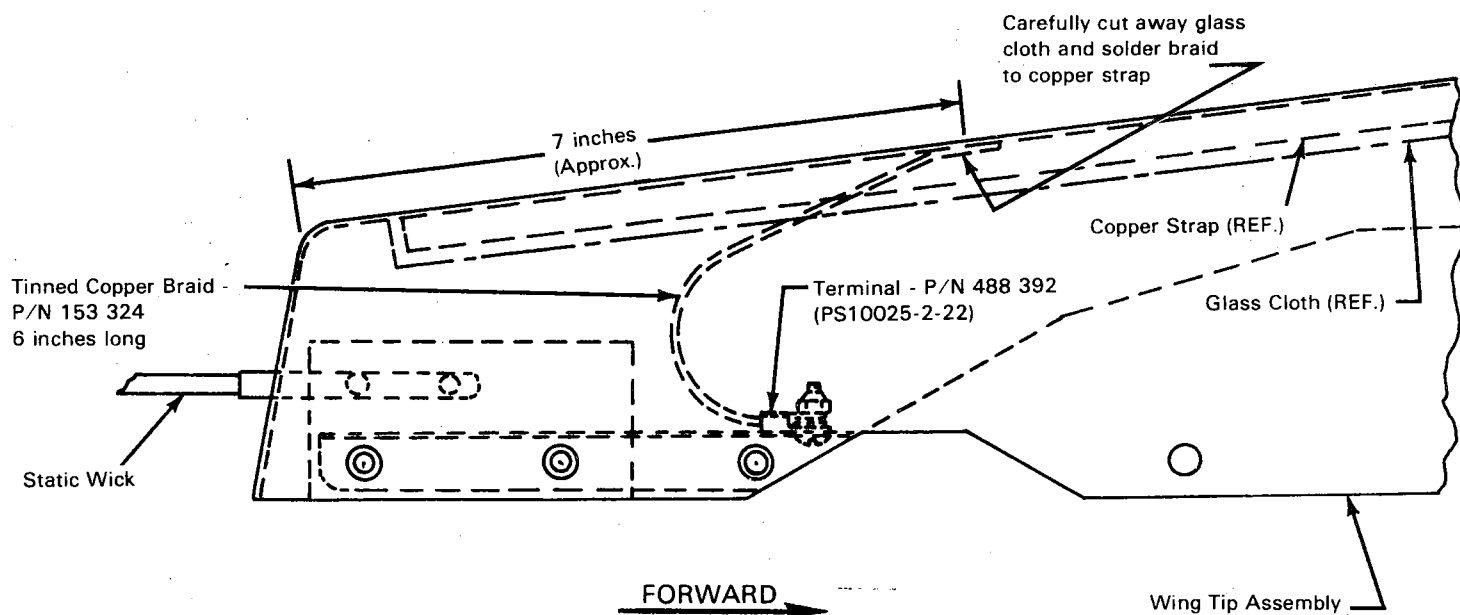
VIEW LOOKING DOWN  
(Left Side Shown, Right Side Opposite)

The wing tip static wick ground path was not provided on the affected aircraft. This Service Release provides instructions to incorporate a ground strap between the wing tip and the wing structure on non tip tank-equipped aircraft. Navigation and communications capability can be impaired under certain atmospheric conditions if static wicks are not properly grounded to the aircraft structure.

1. Remove both wing tips.
2. Reference Sketch A, fabricate and install in each wing tip a 6-inch length of 13/64 I.D. tin plated copper braid ground strap. Clean all paint from around both sides of the tooling hole in wing tip mounting rib, and alodine the bare aluminum prior to attaching the ground strap. Secure the ground strap to the rib using hardware as illustrated.

3. Inside of each wing tip, running chordwise, is a one inch wide copper lightning diverter strap held in place by a covering of glass cloth, approximately seven (7) inches forward of the wing tip trailing edge. Cut through the glass cloth to expose a small area of the diverter strap. Expose enough of the diverter strap to make a soldered connection to the copper braid. (Refer to Sketch A.)
