S.A. 31T2-6

Subject: Avionics Bay Door Seal and Protective Blanket Installation

Model Affected: PA-31T2 Cheyenne II XL

Serial Numbers Affected: 31T-8166001 through 31T-8166012

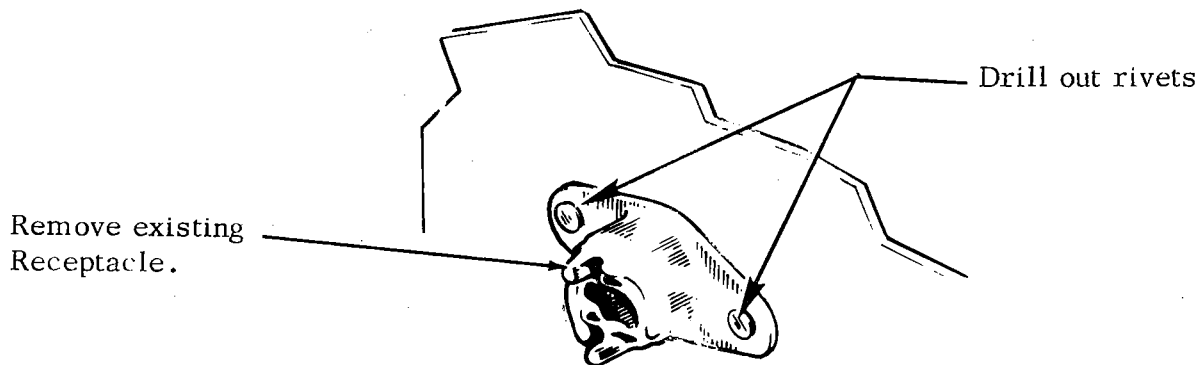
SKETCH I

Purpose: A field report indicates that water could leak around the access door on the left side of the nose section and enter the avionics bay. Exposure to moisture could damage avionics equipment. This Service Release provides instructions to improve the sealing around the access door and to install a protective blanket around avionics equipment.

1. Replace the twenty-four (24) Camloc receptacles on the avionics bay door frame with closed type receptacles as follows:
 - a. Drill out the two (2) rivets attaching each of the receptacles to the door frame, and remove the receptacles (Sketch I).
 - b. Attach twenty-four (24) new closed type 40R12-2 Camloc receptacles (Piper Part No. 584 219) at each existing receptacle cutout. Use two (2) MS20426AD4-5 rivets (Piper Part No. 420 723) at each receptacle. Seal as shown (Sketch II).
2. Install protective blanket (Piper Part No. 01312-03) as follows (Refer to Sketch III).
 - a. Install the hook portion (180 410) of Velcro Tape in the corner of the door frame. Use Carboline neoprene F1 Adhesive or equivalent (Contact cement).
 - b. Install blanket (01312-03) as shown, using 6-inch segments of trim strip (189 379).
3. Make appropriate logbook entry of compliance with this Service Release.
