VENDOR SERVICE PUBLICATION

**SUBJECT:** Hartzell Propeller Products Division, Service Advisory No. 39, dated August 18, 1986

**Inspection and Reinforcement of B.F. Goodrich  
Propeller De-Ice Terminal Clamp Assembly P/N  
3E1883-2.**

NO. - E-85-73  
ISSUED - 6-6-86  
REVISED -

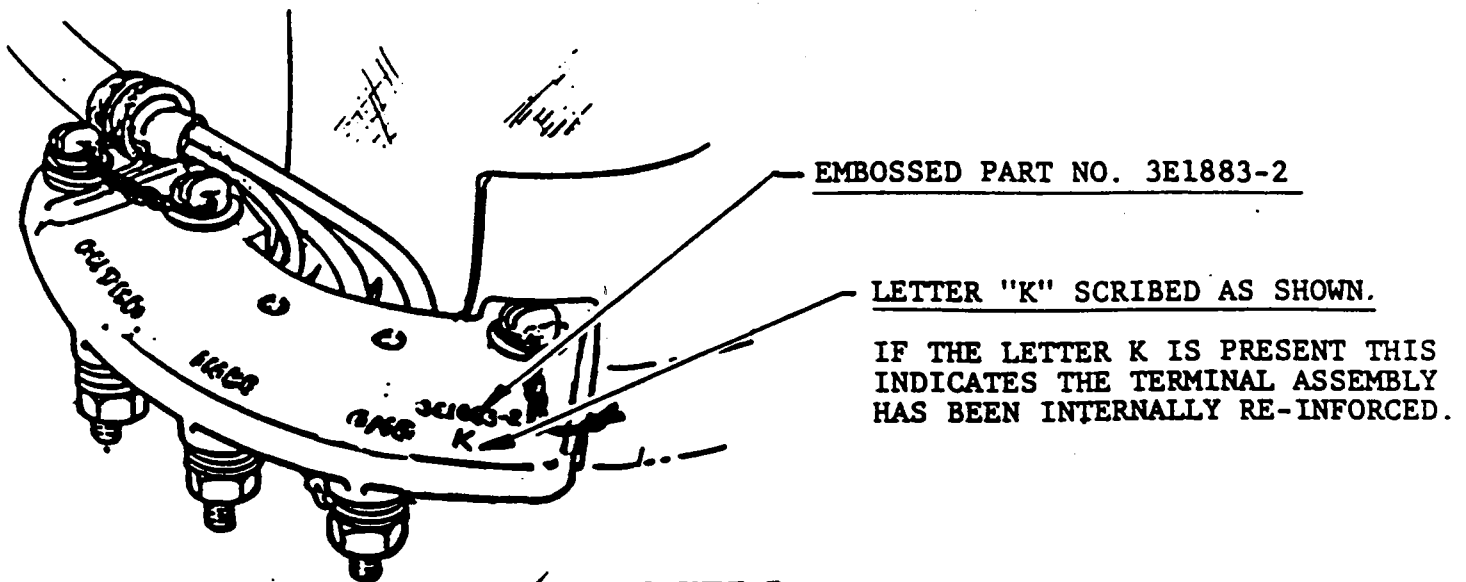
FIGURE 1a

- DISCUSSION: a) If the terminal clamp assembly is black and is identified as  
(CONTINUED) part number 3E1883-2, it is factory reinforced.
- b) If the terminal clamp assembly is lightgray and has the letter K scribed below the part number (Ref. figure 1a), it is factory reinforced.

- a) Visually inspect each terminal clamp assembly in the area below the embossed 3E1883-2 part number. If the Letter 'K' is scribed as shown in Figure 1-a or if the terminal clamp is black and identified as part number 3E1883-2 nothing further is required. (Ref: DISCUSSION)
- b) If the Letter "K" is not present and the clamp is lightgray in color, visually inspect the assembly for any noticeable cracks. (Ref. Figure 1-b)

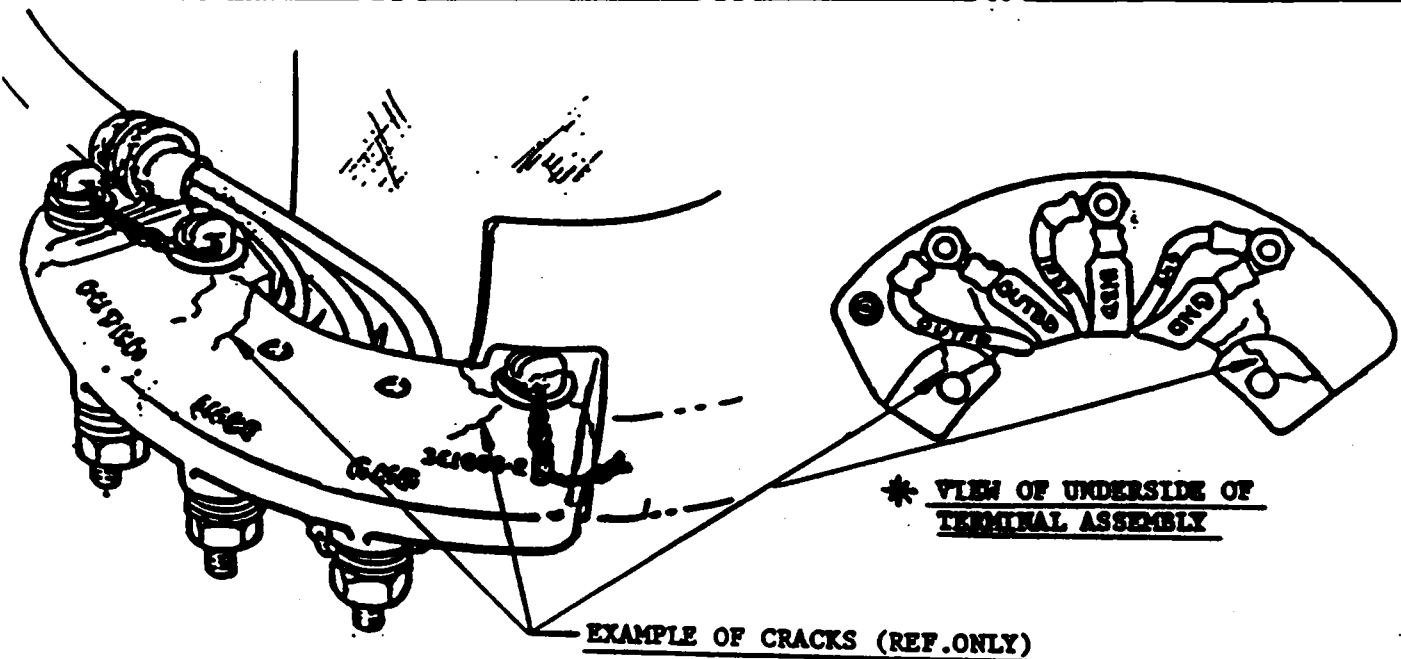
FIGURE 1b.

If any sign of cracking or separation is present, the terminal assembly must be replaced. If the terminal assembly is sound, i.e. no cracks, it is not necessary to replace the assembly as it can be reinforced using the reinforcement kit.

\* TO INSPECT THE UNDERSIDE OF THE TERMINAL ASSEMBLY:

1. REMOVE SAFETY WIRE.
2. LIFT THE ASSEMBLY AND INSPECT AROUND THE ATTACHMENT HOLES AND STANDOFF PADS. IT IS NOT NECESSARY TO REMOVE THE LEADS AT THIS TIME. (FOR REINSTALLATION SEE FIGURES II AND III.)

NOTE: IF THE TERMINAL ASSEMBLY HAS ONE OR MORE CRACKS AS SHOWN IN THE EXAMPLE THE ASSEMBLY MUST BE REPLACED.

Any terminal clamp assembly that shows signs of damage must be replaced and should not be reinforced. To determine if the assembly should be replaced or reinforced a complete inspection of the terminal assembly is mandatory.
