SERVICE LETTER

No. 833

Piper Aircraft Corporation

Cabin Pressurization System Rupture Disc
Elimination

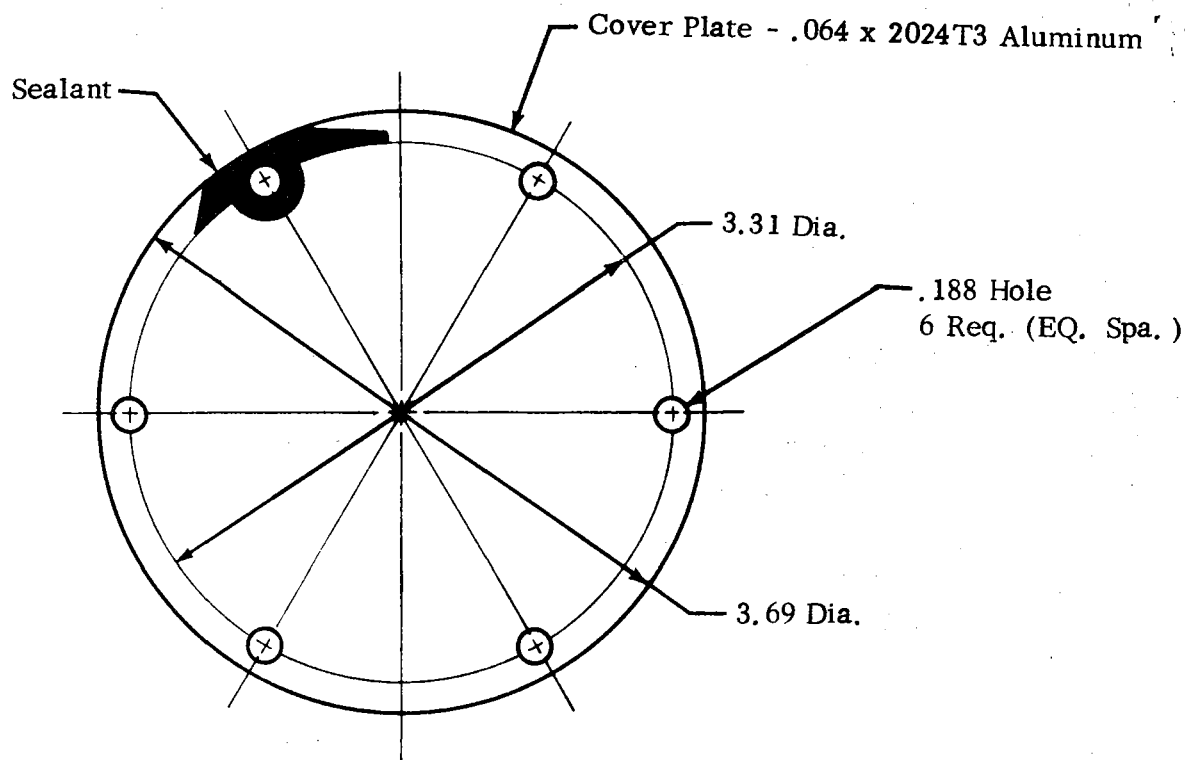
COVER PLATE DETAIL (P/N 48893-02)

Purpose: The current cabin pressurization system on the above referenced models no longer requires the rupture disc assembly (formerly installed on rear of aft fuselage pressure bulkhead, sta. 274). Further, Rupture Disc Assembly, Piper Part Number 48683-00 is no longer supplied for field replacements through the factory Customer Service Sales Division.

1. Remove left access panel, located between sta. 274 and sta. 296, from aft fuselage.
2. Locate and remove the rupture disc assembly, installed on rear of sta. 274 pressure bulkhead, by removing the six screws and washers.

3. Remove the rupture disc placards from the forward and aft sides of the pressure bulkhead by drilling out the attachment rivets.
4. Fabricate cover plate per above detail or order plate from Piper Aircraft Corp. under part number 48893-02.

5. Clean cover plate and sta. 274 bulkhead, in the area where the rupture disc assy. and rupture disc placards were removed, with a non-corrosive solvent. Let dry.

6. Apply MIL-S-7502 Sealant (Products Research Comp. PRC-1221 or equivalent) around cover plate and around each hole, as shown on above detail, to make one continuous bead of sealant.

7. Install cover plate on sta. 274 bulkhead with the six screws and washers previously removed.
8. Apply sealant under head of MS20470AD3 rivets and install in rivet holes where placards were attached. (Note: Rivets need not be formed if sealant is allowed time to cure. Check cure time on sealant label.)

9. Reinstall left access panel to aft fuselage.
10. Make proper logbook entry of Service Letter compliance.
