SERVICE BULLETIN

No. 665A

Piper Aircraft Corporation

Subject: Throttle Control Ball Joint Connector and Rod End

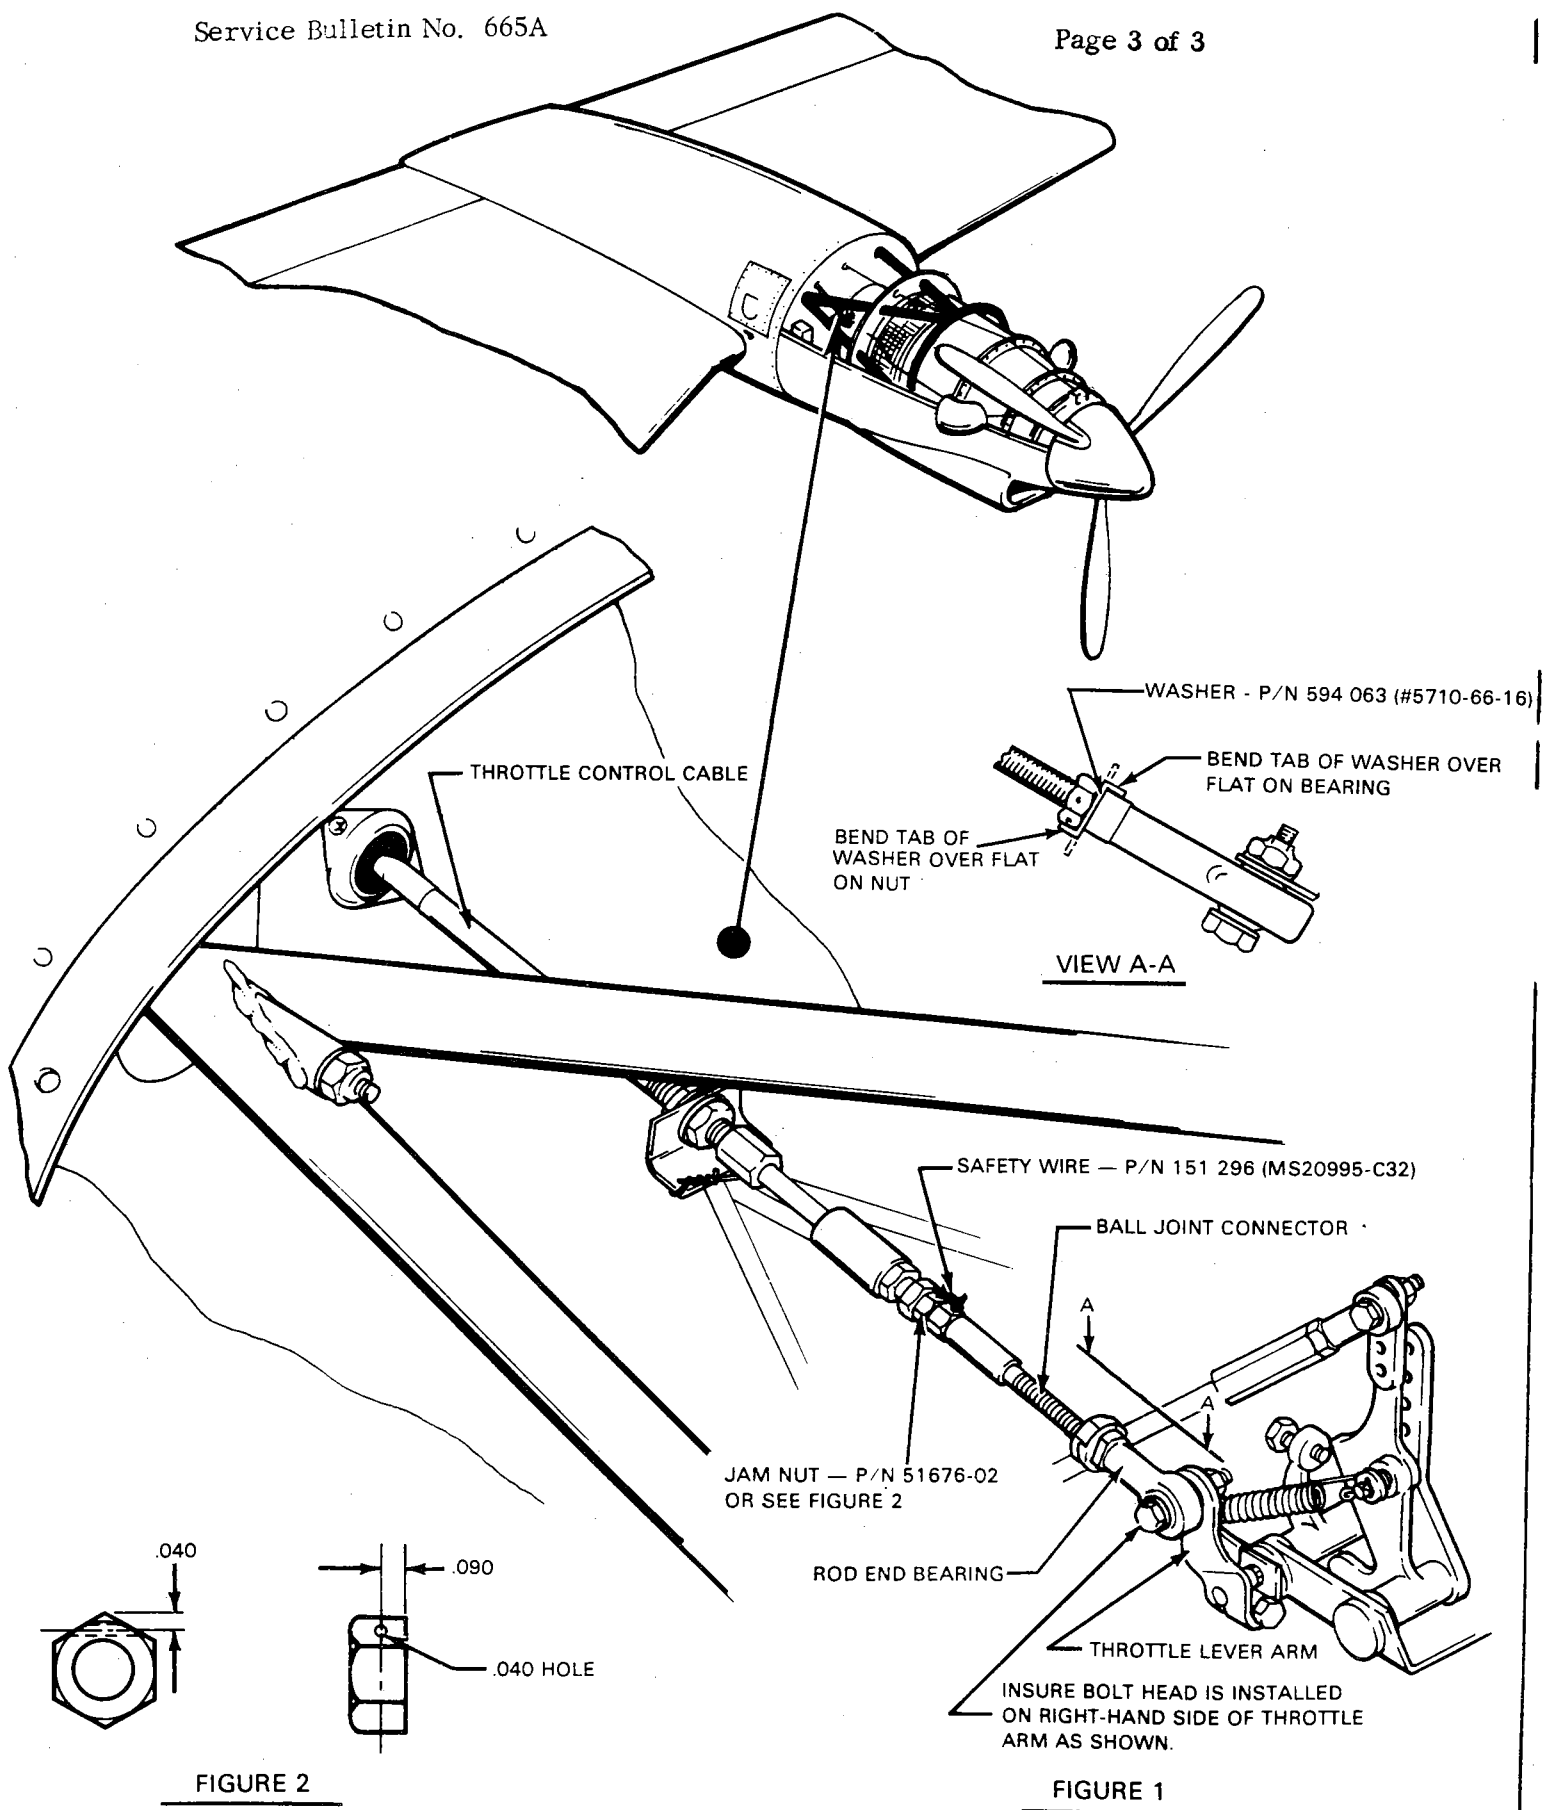
A field report has been received of the throttle control linkage separating at the ball joint connector in the engine compartment. This condition resulted from the ball joint connector jam nut (Piper Part Number 51676-02) not having been properly torqued and safety-wired, allowing the ball joint connector to rotate free from the throttle control cable end. Separation of the ball joint connector from the throttle control cable end will cause the affected engine to go to idle speed.

1. Remove the upper cowl assembly from the left and right engines.
2. Inspect the throttle control cable on each engine, as shown on attached sketch, to determine if ball joint connector jam nut is safety wired.
 - a. If safety wire is installed, as shown on sketch, proceed to Step 3.
 - b. If safety wire is not installed, as shown on sketch, inspect jam nuts for evidence of a drilled hole to accept safety wire. If jam nut/nuts are not drilled, replace with a new jam nut Part Number 51676-02 or refer to Figure 2 for drilling instructions.

3. Install tab washer (Piper Part Number 594 063) between rod end bearing and jam nut as shown in attached Sketch, View A-A. Do not bend tabs until after completing step 4.

Insure bolt connecting rod end bearing to throttle arm is installed as shown on Sketch.

4. Insure jam nuts are secure. Refer to the PA-31T/T1 Maintenance Manual, Section VIII, for proper rigging of jam nuts.
5. Install safety wire P/N 151 296 (MS20995-C32) on aft jam nut, and bend tabs of washer (P/N 594 063) between rod end bearing and forward jam nuts as shown on sketch.
6. Reinstall upper cowl assemblies on engines.
7. Make appropriate logbook entry of compliance with Service Bulletin No. 665A.
