# SERVICE BULLETIN

No. 481A

Piper Aircraft Corporation

Subject: Elevator Assembly Inspection and Elevator Butt Rib Replacement.

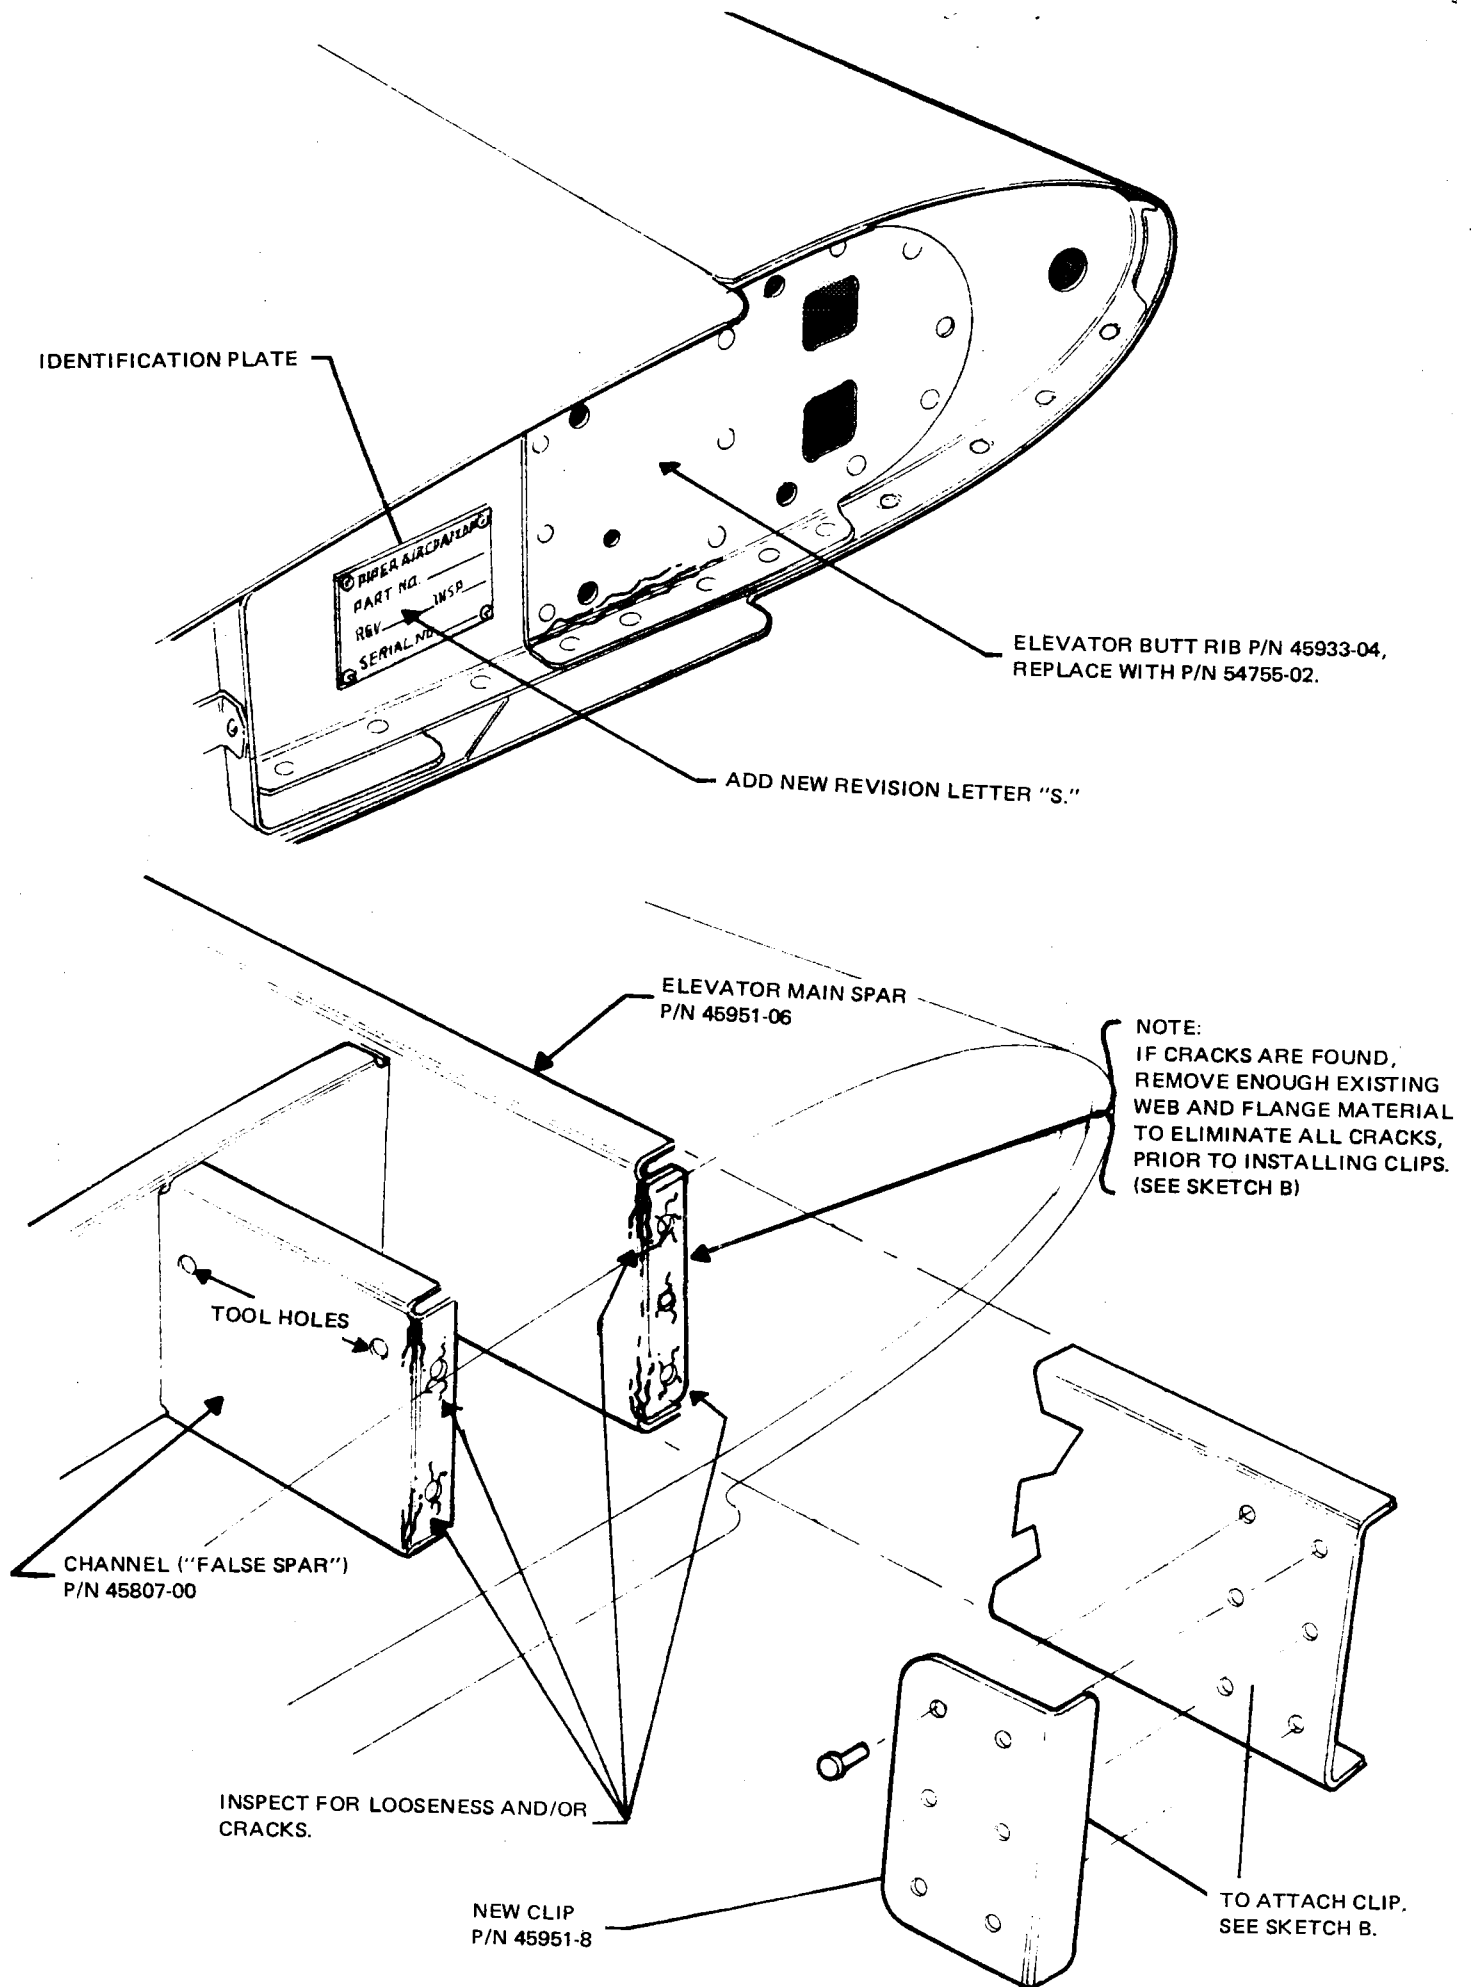
SKETCH A

Reports from the field indicate that cracks can occur in the Elevator Butt Ribs, Elevator Butt Rib - to - Elevator Spar attachment area, and Elevator Outboard Hinge Area.

1. Remove Elevators, reference current PA-31T Service Manual, Section IV, Structures.
  2. Reference attached sketch "A"; remove existing Elevator Butt Ribs, part number 45933-04 and discard. CAUTION: Remove elevator identification plate (stamped metal tag with elevator part number, serial number, etc.) and stamp with letter "S" for revision. Retain for reinstallation on new Elevator Butt Ribs; reference step 6, below.
  3. Reference attached sketch "A"; with concentrated light, inspect inboard end of Elevator Main Spar, part number 45951-06, and Channel ("false spar") part number 45807-00 for cracks around bolt hole perimeters and in flange bend radii.
-

- a. If cracks are found in Elevator Main Spar Tab, remove tab and replace with clip Piper part number 45951-08 as shown on the attached illustrations (sketch "A" and "B").

- b. Reinstall stabilizer tip.
6. Install new Elevator Butt Ribs, Piper part number 54755-02 (two each required per aircraft); NOTE: be sure to install elevator identification plates - marked with revision "S" removed per step 2, above.

NOTE A  
IF REQUIRED, IT IS PERMISSIBLE TO  
TRIM DAMAGED MAIN SPAR WEB TO  
A MAXIMUM OF .29. DO NOT TRIM  
THE UPPER AND LOWER ENDS OF  
THE SPAR FLANGE. MAINTAIN  
RELIEF RADIUS IN BOTH CORNERS.

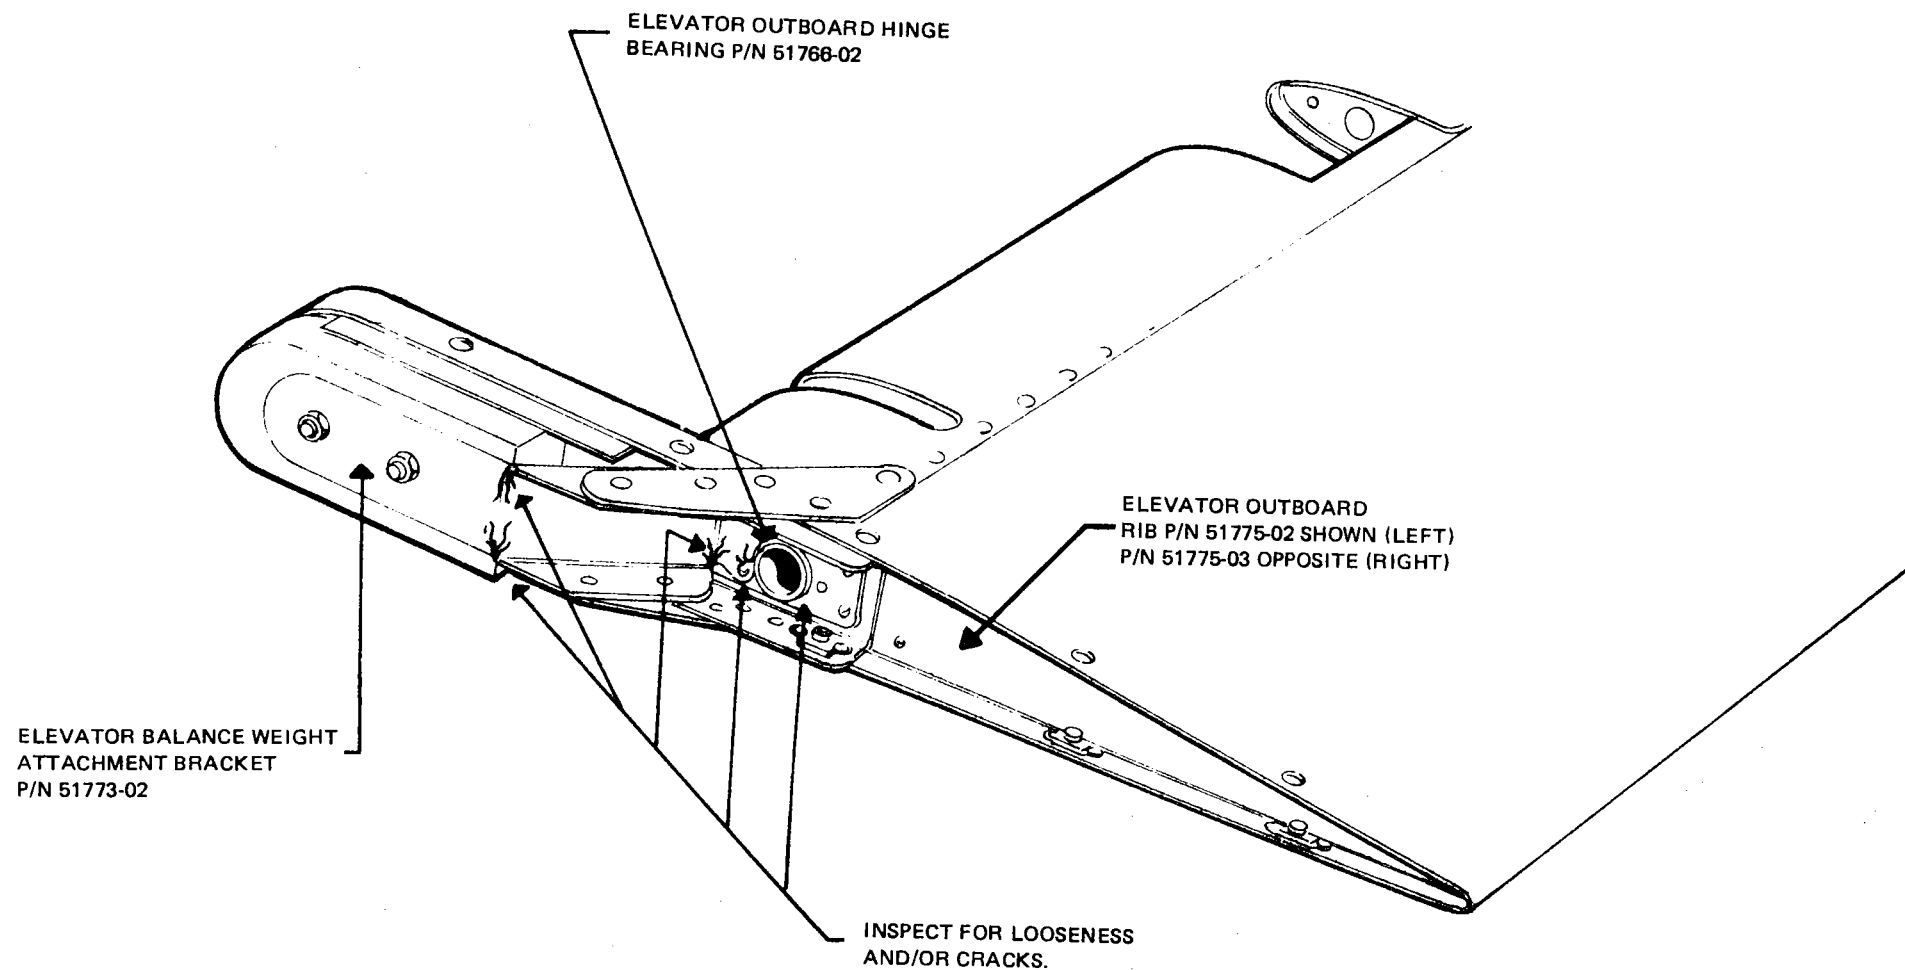
- b. If cracks are found in Channel ("false spar"), part number 45807-00, replace with new like part.
4. Remove elevator tip (reference sketch "C");
  - a. Inspect Elevator Outboard Hinge Bearing Assembly, part number 51766-02 for looseness and/or evidence of cracks in the welded area; if loose and/or cracked, replace.

2. Inspect Elevator Outboard Rib for cracks; if cracked, replace with new like part, part number 51775-02 (left) or part number 51775-03 (right).
  - b. Inspect Elevator Balance Weight Attachment Bracket, Piper part number 51773-02 for looseness and/or evidence of cracks at bend radii; if loose and/or cracked, replace.

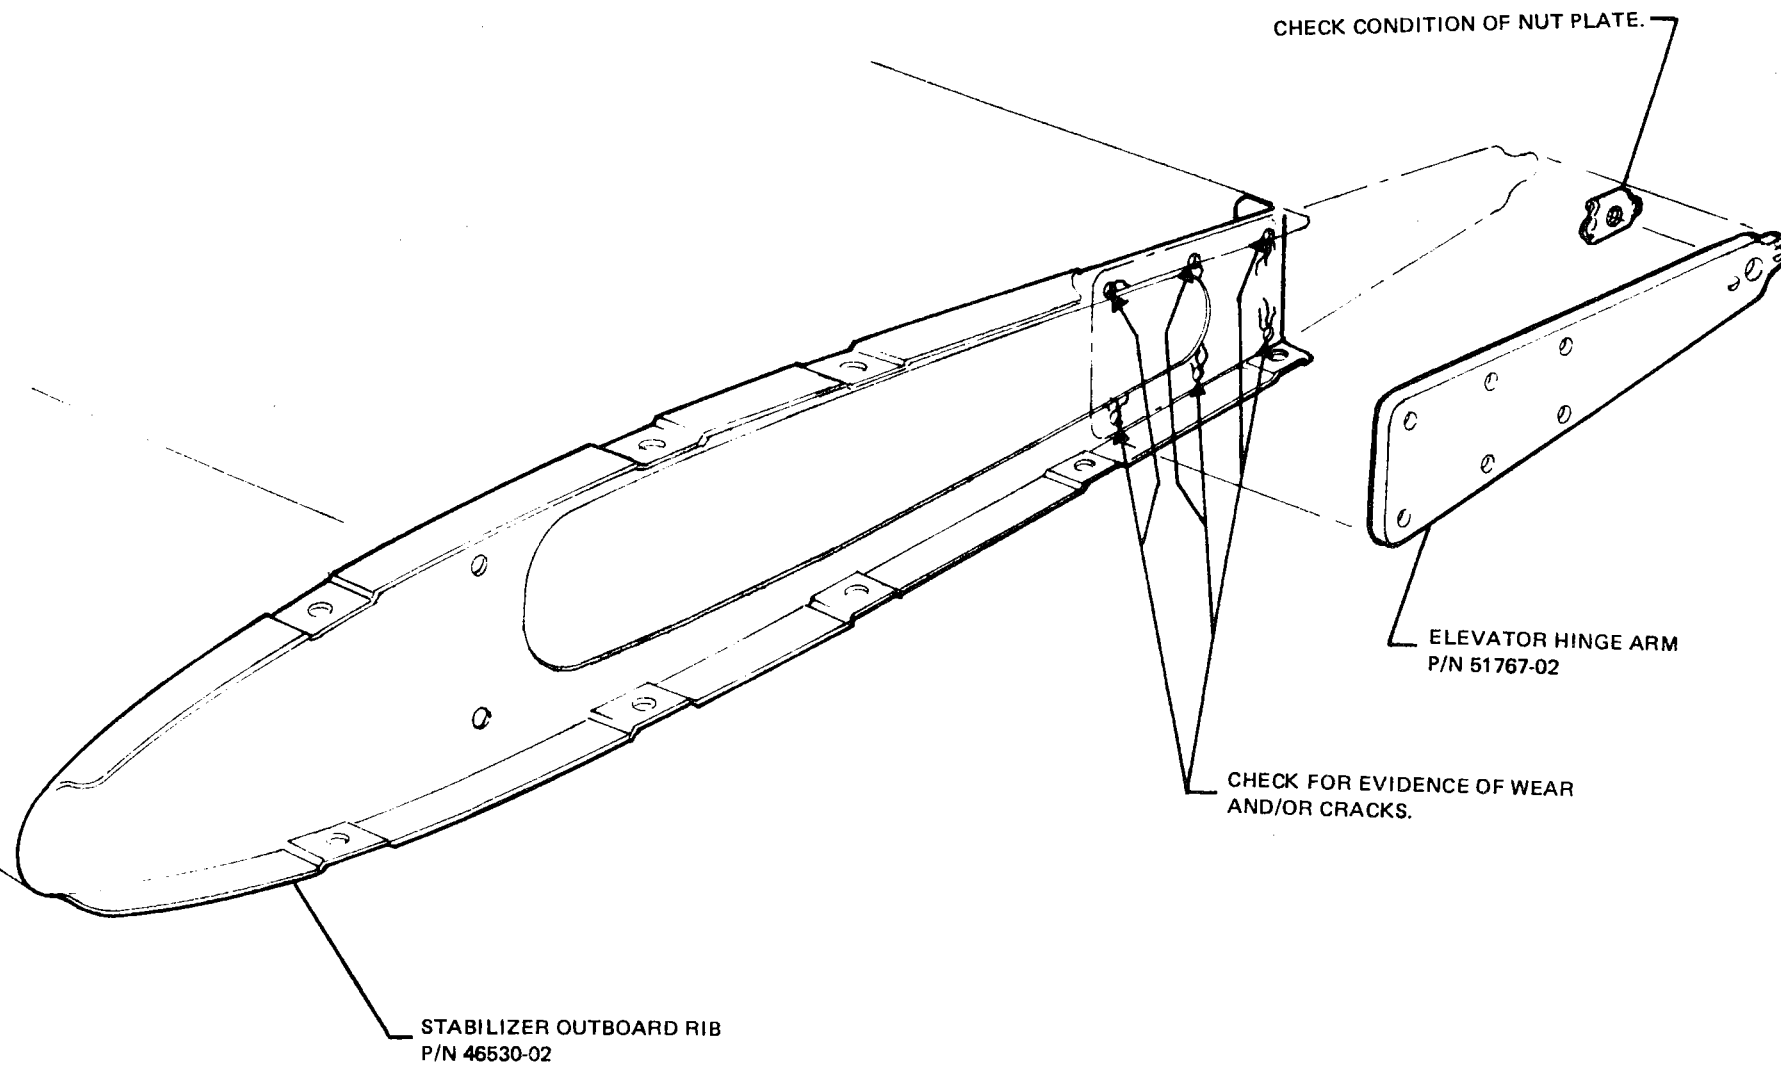
SKETCH D

- c. Reinstall elevator tip.
5. Remove stabilizer tip (reference sketch "D");
  - a. Inspect Stabilizer Outboard Rib, Piper part number 46530-02 (aft, near the hinge attachment point and Elevator Hinge Arm Assembly, Piper part number 51767-02 for evidence of wear and/or cracks; if loose and/or cracked, replace.
