Piper Aircraft Corporation

SERVICE *No. 822* BULLETIN

Special Inspection of Hydraulic Hose,
Piper Part Number 17766-02 (465-138)

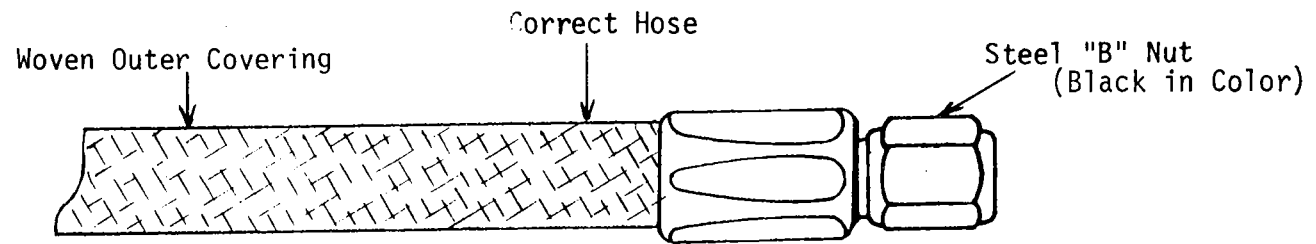
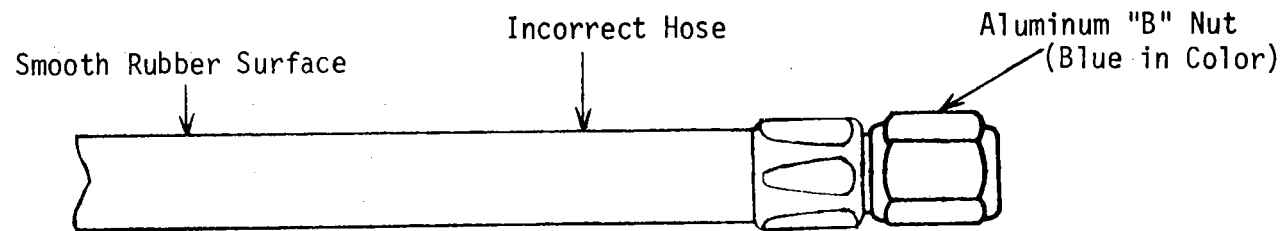
SKETCH "A"

It has been determined that a group of hydraulic
hoses, Piper Part Number 17766-02 (465-138), were manufactured using material
that does not meet the pressure requirements for operation in the aircraft
hydraulic system. If an installation has been made using these hydraulic hoses,
premature failure will result in a loss of hydraulic capabilities.

1. Refer to the appropriate aircraft parts catalog and maintenance manual for location and quantity requirements for specific model application.
2. Gain access as required by model for visual inspection of each affected hose. See Sketch "A" attached.
3. Replace any hose found to be of incorrect material prior to further flight.
4. If replacement is required by inspection, perform a hydraulic systems function check per the appropriate maintenance manual.
5. Make appropriate logbook entry of compliance with this Service Bulletin.
