SERVICE LETTER

No. 790

Paralleling Relay Terminal Strip Tab
Modification.

PA-31T Cheyenne

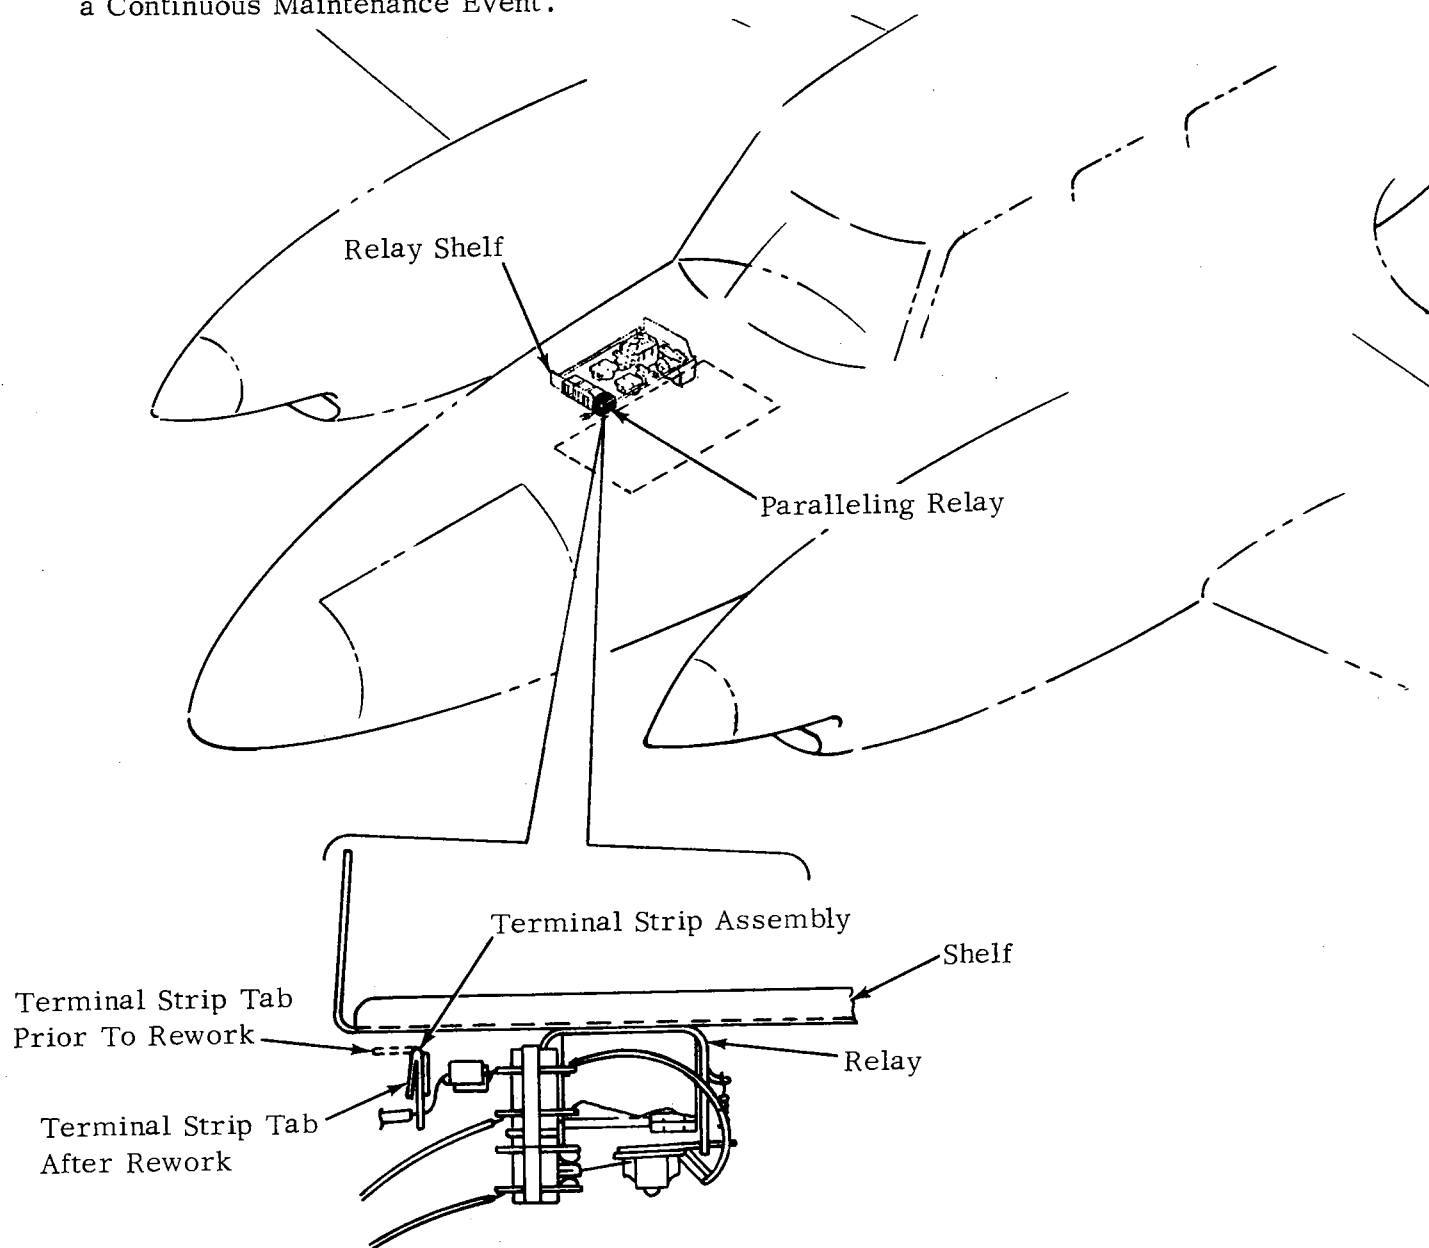
During routine factory systems testing, it has come to our attention that, by turning the generator bus tie switch "OFF" a short can occur at the paralleling relay terminal strip tab if the tab contacts the adjacent paralleling relay supporting shelf.

1. Gain access to relay shelf by removing access panel from right side of fuselage nose section.
2. Remove Royalite cover from relay shelf.
3. Locate paralleling relay and rework terminal strip by bending tab down from shelf as shown. Wrap electrical tape around complete terminal strip after tab is bent down from shelf.
4. Reinstall Royalite cover and fuselage access panel.
5. Make proper Logbook entry of modification.
