# SERVICE BULLETIN

No. 651

Piper Aircraft Corporation

Control Shaft Roll Pin Inspection

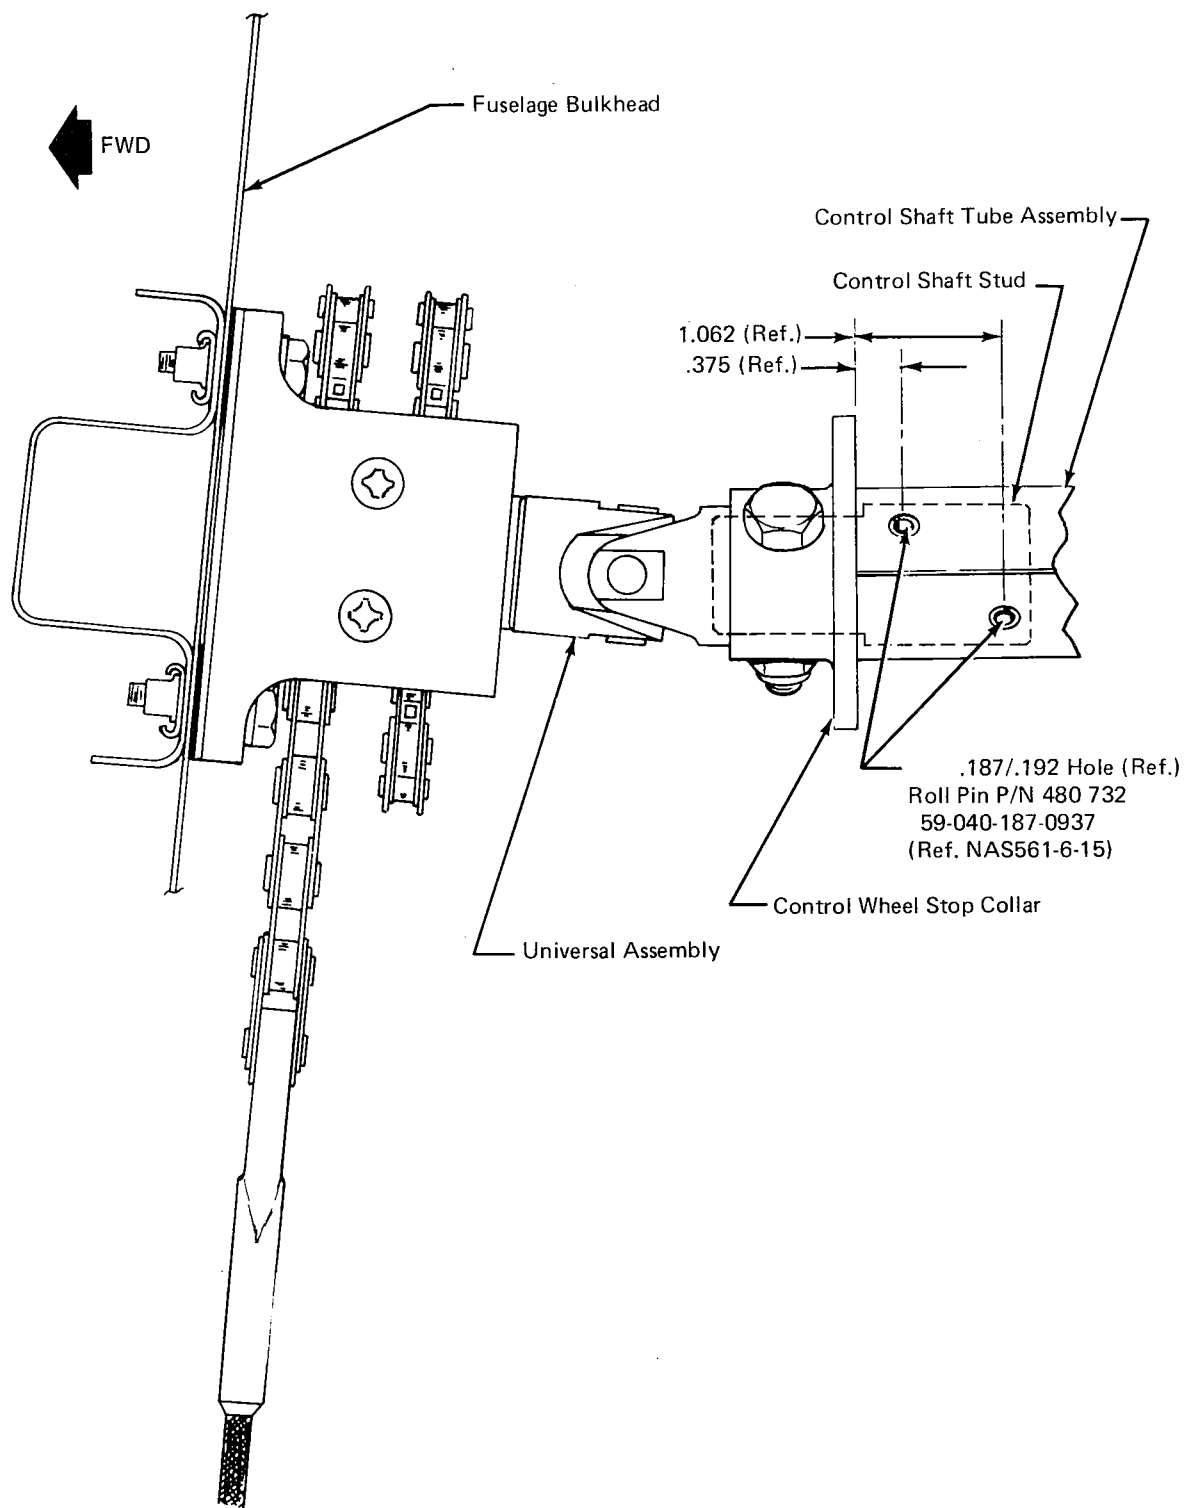
A field report has been received which indicates that the Roll Pins (Piper Part No. 480 732, two (2) per control wheel shaft) which secure the control shaft stud to the control shaft square tube may not have been installed. Absence of the subject roll pins could result in the separation of the control shaft square tube from the stud and subsequent impairment of aileron control function of the affected control wheel.

1. Secure control wheels in aft position.
2. Gain access to the control shaft square tube assembly-to-stud connection, located just aft of the control wheel stop collar. (See Sketch).
3. Deflect controls as necessary to inspect the forward end of the control shaft square tube assembly to determine that two (2) roll pins are installed.

4. If one or both roll pins are missing, replace roll pins as required.
5. If roll pin holes are not present in the shaft or the stud, insure that the shaft is fully engaged on the stud, and drill holes as shown on sketch before installing roll pins.
6. Make appropriate logbook entry of compliance with Service Bulletin No. 651.
