Service Letter No. 388

SUBJECT: Removal of Carburetor Heat Shroud Screen

MODELS AFFECTED: PA-23-250 Aztecs, Serial Nos. 27-1 to 27-504 incl., PA-23-250 Aztec (six place), Serial Nos. 27-2000 to 27-2253 incl., PA-23-235 Apache, Serial Nos. 27-505 to 27-517 incl.

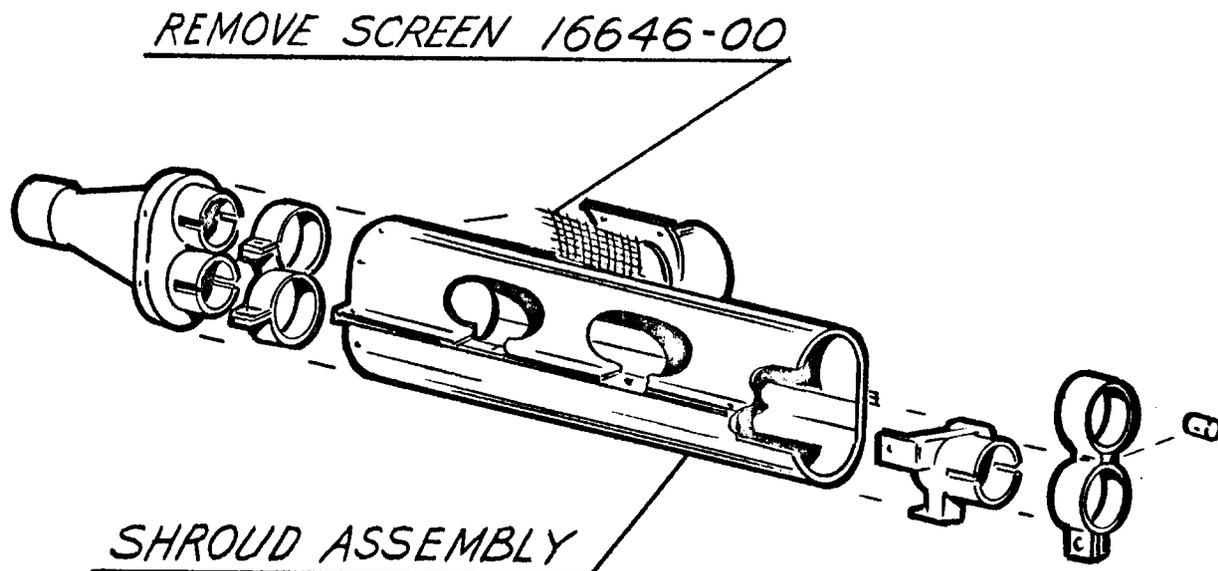
A few reports from the field indicate there is a possibility that the subject screen (see sketch below), located on each engine in the outboard exhaust shroud assembly, may over a period of time show evidence of deterioration.

Service experience has indicated that this screen is not necessary, therefore, it is suggested the screen be removed from each engine shroud assembly, on aircraft listed above, at the next 100 hour inspection.
