SERVICE No. 214 BULLETIN

Piper Aircraft Corporation

SUBJECT: Removal of Vanes from Throat of Carburetor Air Box

MODELS AFFECTED: PA-23-250 Aztecs, Serials 27-1 to 27-504 inclusive
PA-23-235 Apaches, Serials 27-505 to 27-550 incl., 27-552,
27-553, 27-555, 27-557 and 27-558
PA-23-250 Aztecs (six place), Serials 27-2000 to 27-2307 incl.,
27-2309 to 27-2315 incl., 27-2320, 27-2321, and 27-2324 to
27-2328 incl.

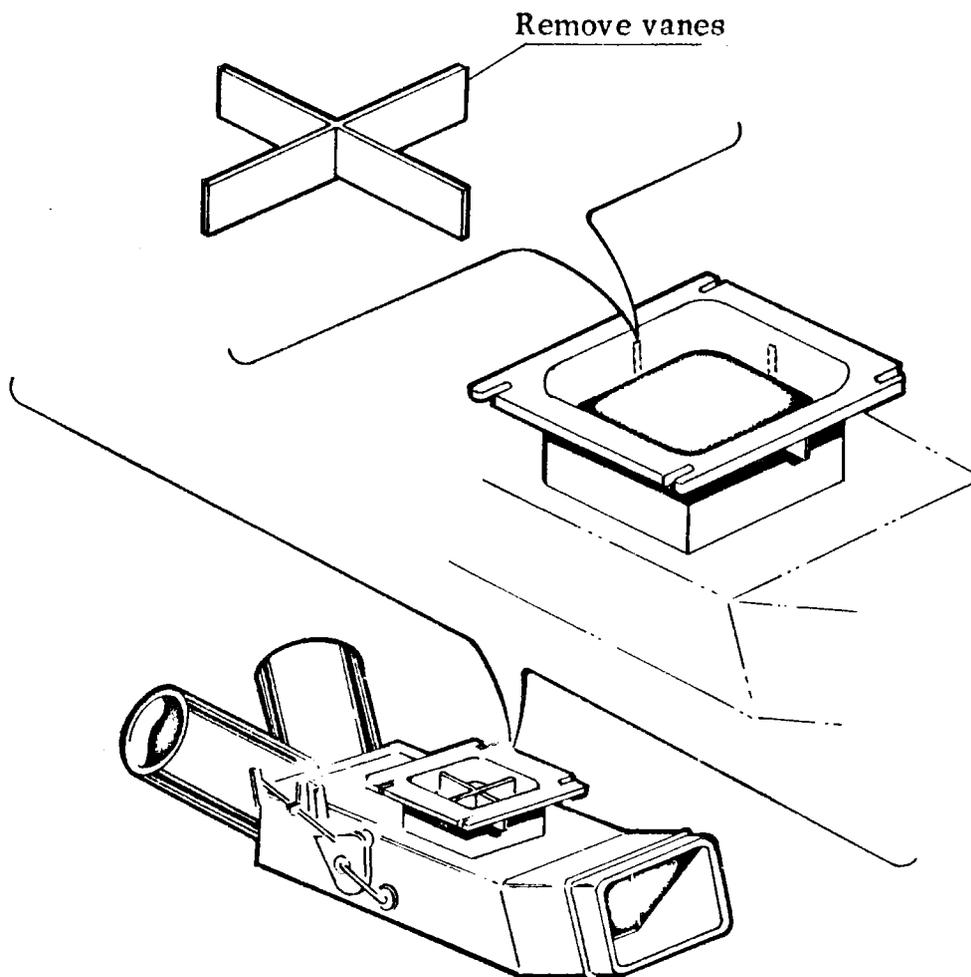
A few reports have been received by the Service Department indicating that cracks have occurred in the vanes located in the throat of the carburetor air box, part number 16463-00. There have also been a few instances where a piece of the vane has broken off and lodged in the carburetor, causing a reduction in engine power.

Exercise caution when removing the vanes so as not to damage the carburetor air temperature bulb.

The vanes may be removed in the following manner:

1. Remove the carburetor air scoop assembly.
2. Remove the carburetor air filter.
3. Remove the clamp at the carburetor air box end of the carburetor air filter coupling. Compress the coupling and lay it on the top of the box.
4. With a blunt bladed tool, such as a wide blade screw driver (do not use a chisel), gently tap each side of the vanes at the welded attachment point until it breaks loose from the air box throat. (Due to the softness of the metal vanes they will generally break clean. However, be certain that there are no ragged edges left in the throat and that all particles of metal have been removed from the area.)
