SERVICE LETTER

No. 705

Piper Aircraft Corporation

Subject: Modification of Turbocharger Oil Tanks and Related Installation -- reference attached AiResearch Service Bulletins No. 14.1.10 and 14.1.11, both dated February 6, 1974.

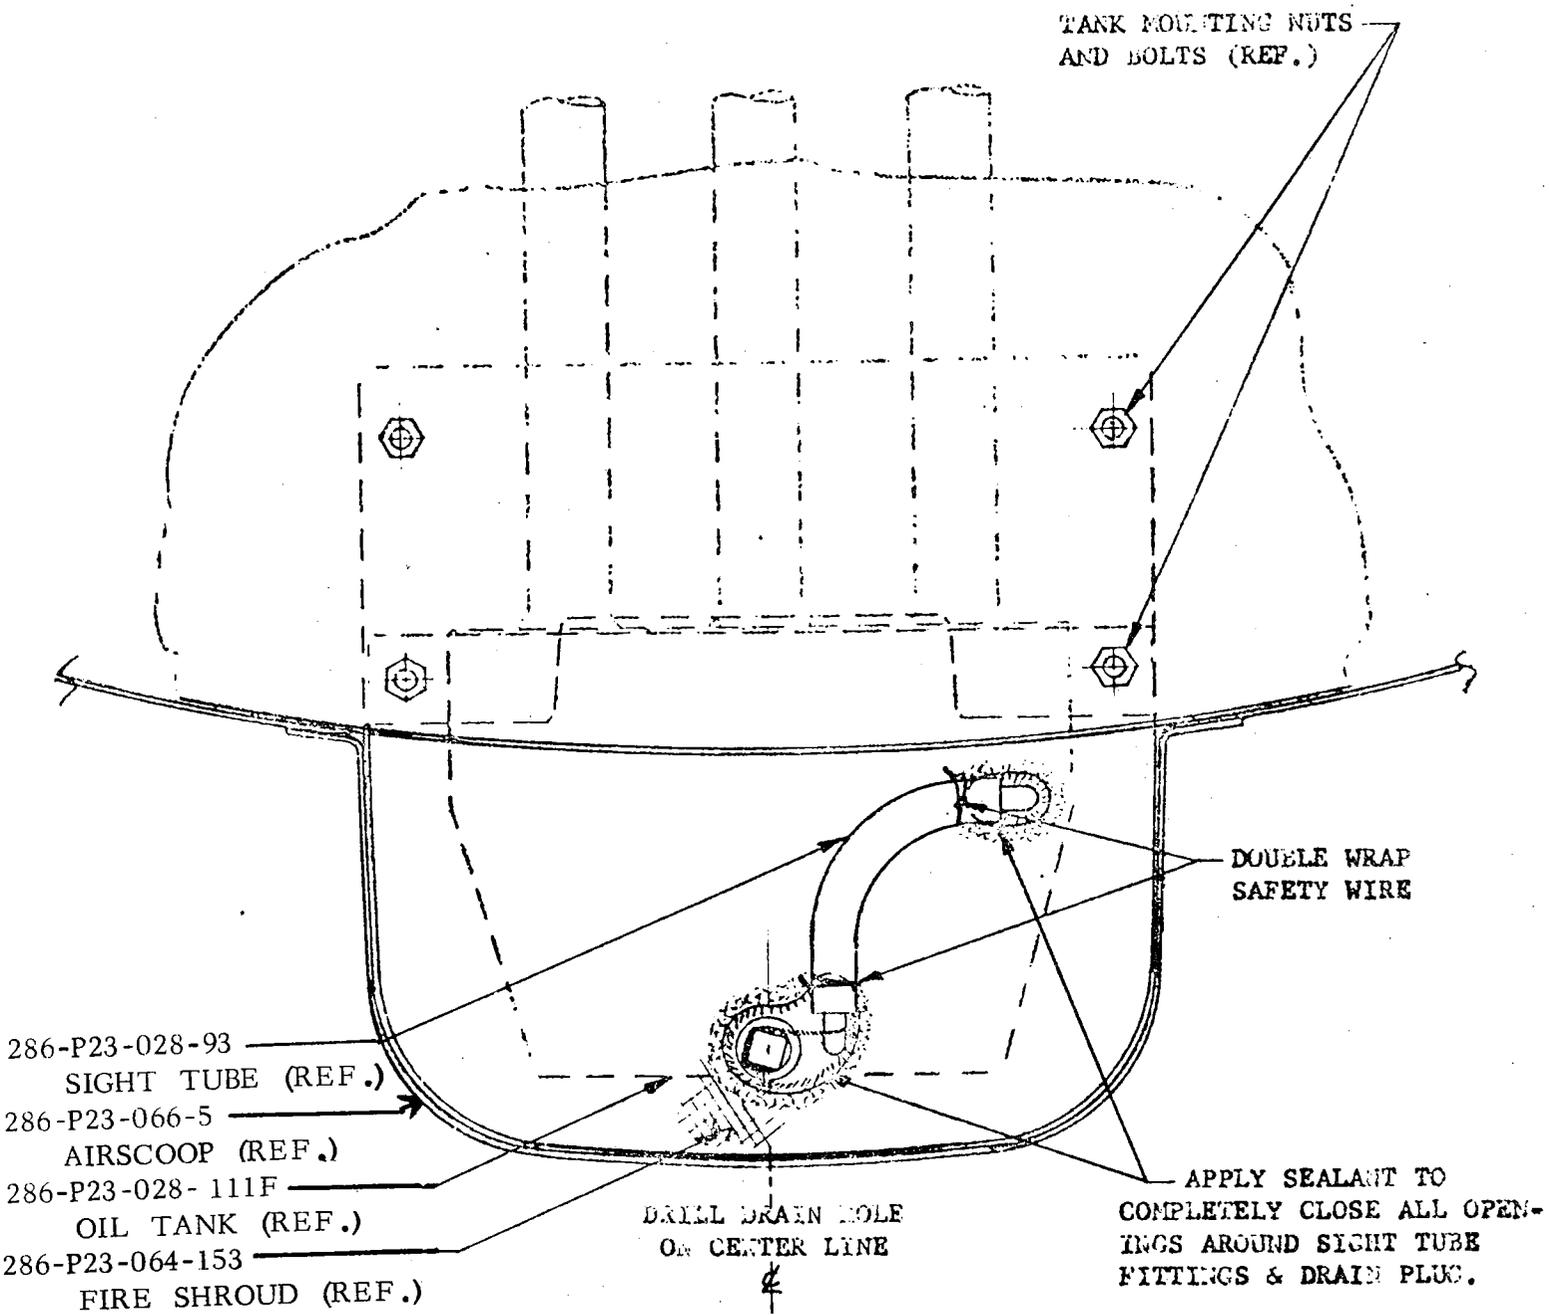
FIG. 1

VIEW LOOKING FWD.
TYP, BOTH ENG'S.

- F. Seal openings around sight tube fittings with supplied sealant as illustrated on Figure 1, L.H. R.H. Follow application directions on container. (Reference - Piper Service Bulletin No. 375 dated June 20, 1973.)

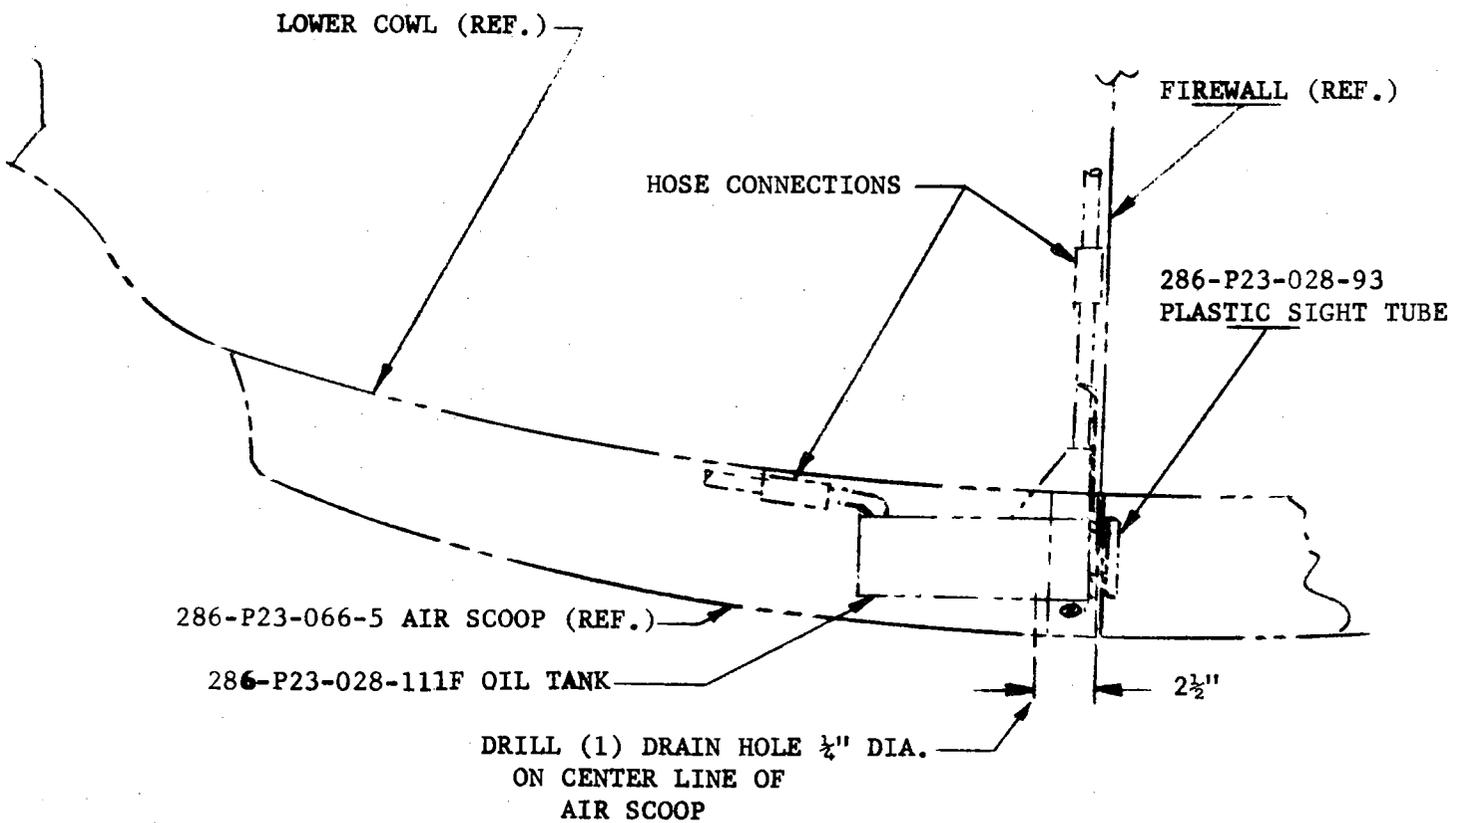
FIG. 2

SIDE VIEW
TYP. BOTH ENG'S.

- G. Drill drain hole (1) on bottom air scoop (286-P23-066-5) as illustrated on Figure 2. L.H. R.H.

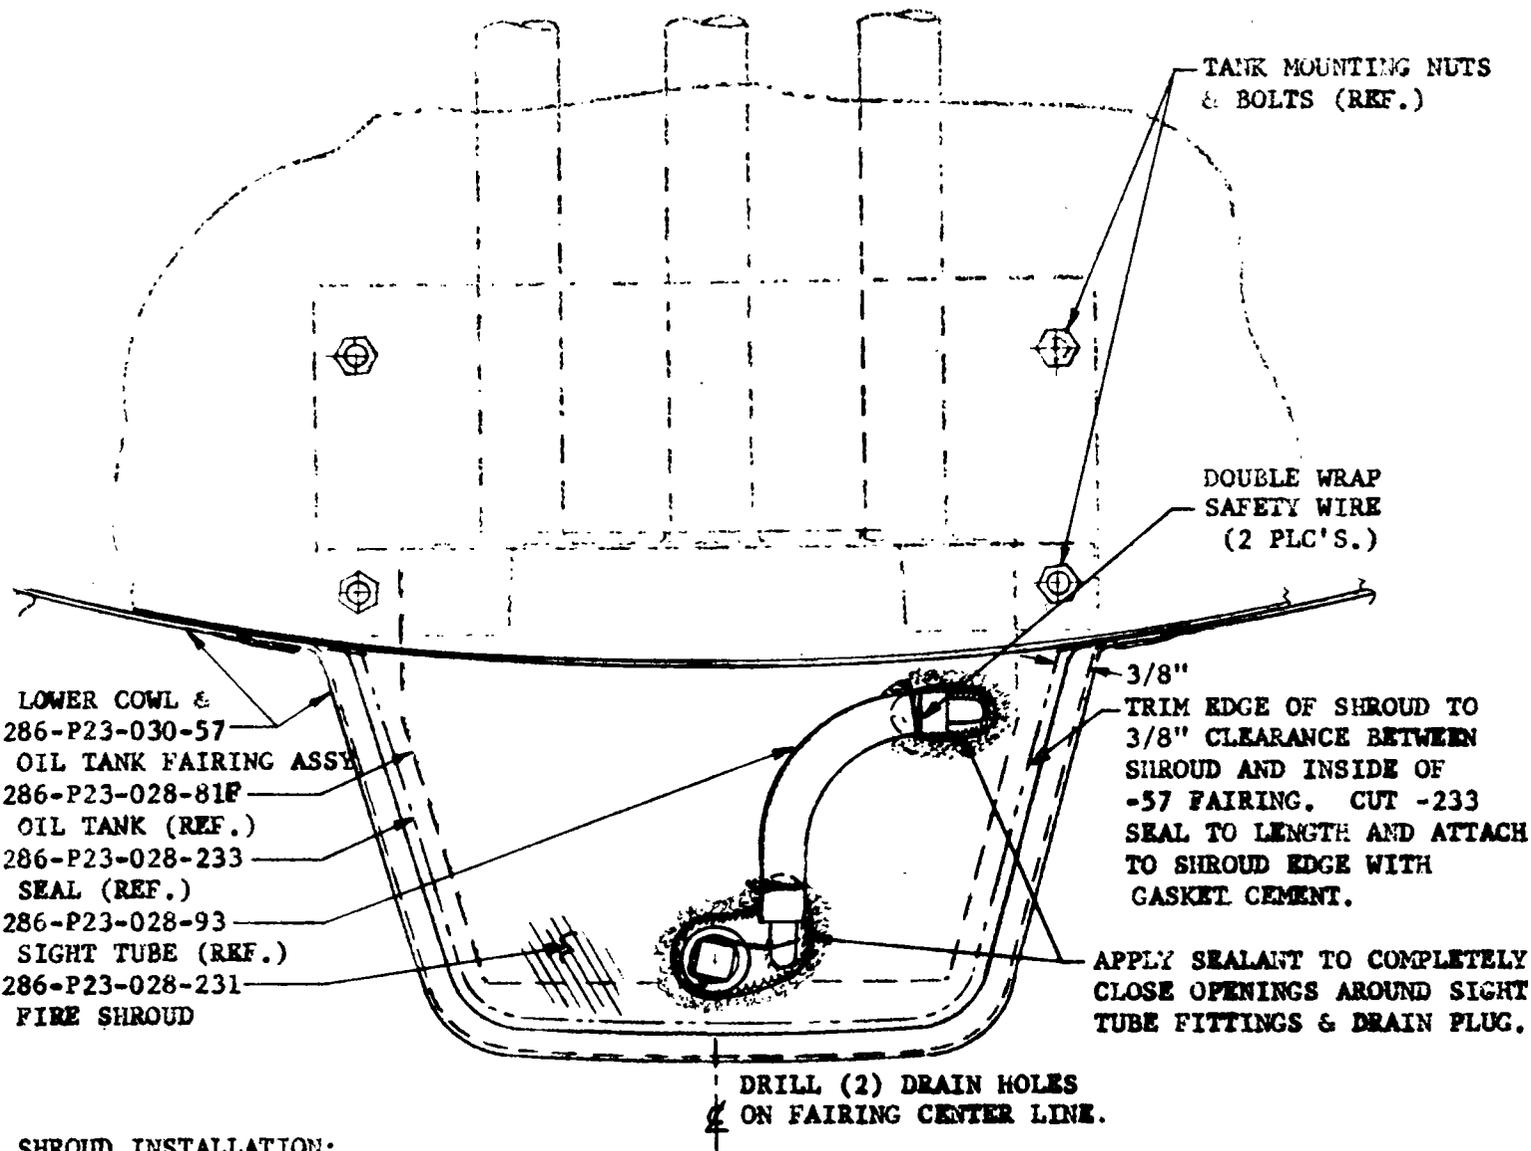
FIG. 1

SHROUD INSTALLATION:

- A. SHROUD TO BE SANDWICHED BETWEEN EXISTING ENGINE FIREWALL AND LOWER HALF OF OIL TANK MOUNTING PLATE.
- B. CHECK LOCATIONS OF (2) .09 PILOT HOLES IN SHROUD TO MATCH (2) LOWER BOLT HOLES IN OIL TANK PLATE. DRILL HOLES TO ACCEPT 3/16" BOLTS.
- C. LOCATE SHROUD AS IN (A), TRIM UPPER EDGE AS REQUIRED TO PERMIT ATTACHMENT TH (2) LOWER TANK BOLTS.

VIEW LOOKING FWD.
TYP. BOTH ENGS.

- D. Install lower fireshroud (286-P23-028-231) as illustrated on Figures 1 and 2.
- E. Install improved oil tank (286-P23-028-81F) in reversed order from Step C to A.

- F. Install plastic oil level sight tube (286-P23-028-93) as installed on old tank. R.H. L.H.
- G. Seal openings around sight tube fittings with supplied sealant as illustrated on Figure 1. L.H. R.H. Follow application directions on container.

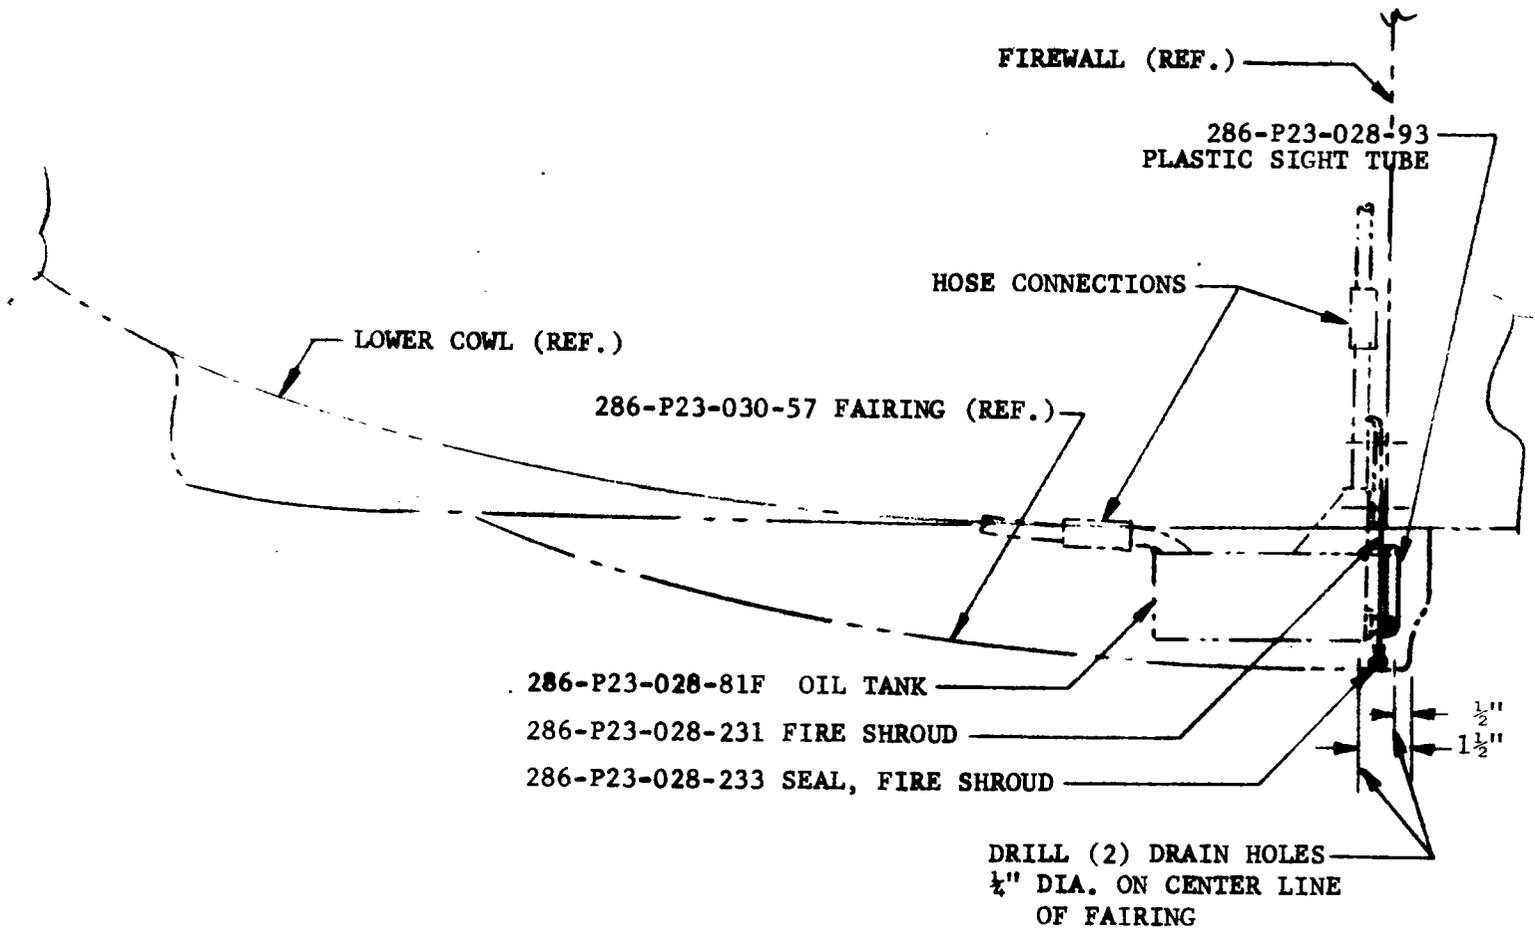
FIG. 2

SIDE VIEW
TYP. BOTH ENG'S.

- H. Drill drain holes (2) on fairing, oil tank (286-P23-030-57) as illustrated on Figure 2. R.H. L.H.
