Service Letter No. 407

SUBJECT: Installation of Roll Pin in Rudder Trim Tab Control Rod and Inspection of Rudder Trim Tab Control Rod

MODELS AFFECTED: PA-23 and PA-23-160 Apaches, Serial Numbers 23-1 to 23-2046 incl.

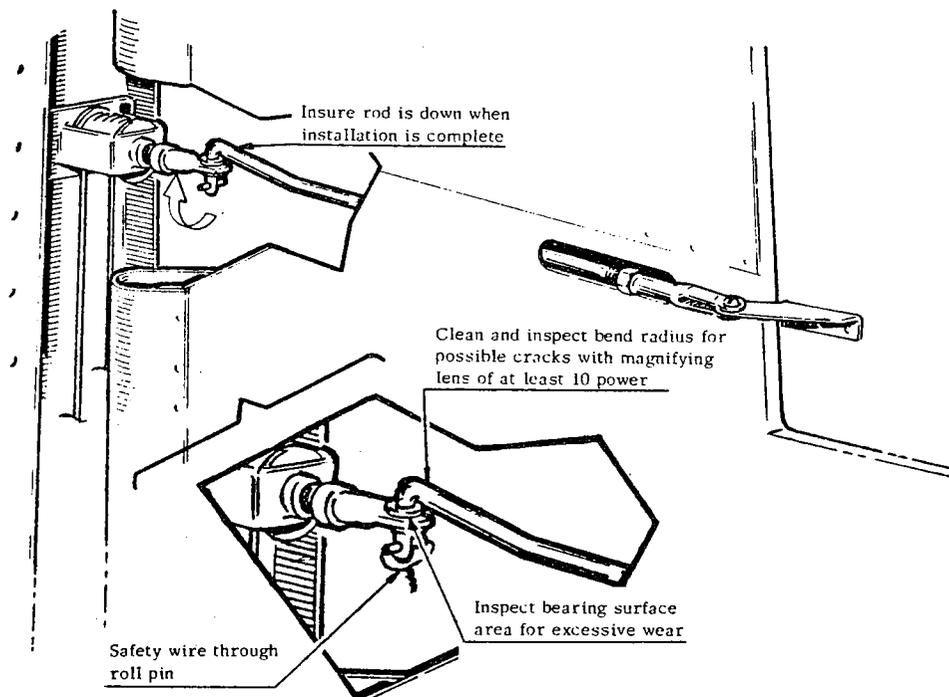
1. Rotate the rudder trim handle in the cockpit for full right trim.
2. Remove the nut and bolt which connects the rudder trim tab and trim control rod.
3. Rotate the trim tab control rod 90° clockwise as shown on sketch.

4. Remove present cotter pin and washer. Remove the trim control rod from the rudder and inspect as per sketch.
5. Prior to installing the rod redrill the cotter pin hole to .081; to accommodate the roll pin.
6. Reinstall the trim rod and install roll pin. Safety roll pin as shown with .032 steel safety wire.
7. Rotate the trim rod 90° counter-clockwise and reinstall nut and bolt at trim tab horn.

A report has been filed with the Service Department indicating that the end of the rudder trim tab control rod, part number 17271-00, that attaches to the rudder trim tab screw, part number 18453-02, has slipped out of the screw due to the loss of the cotter pin. To preclude a recurrence of this nature, it is requested that a steel roll pin, part number 480 728, be installed in lieu of the cotter pin on all Apaches, serial numbers listed above.

An inspection shall be made, within the next 50 hours of operation and every 100 hours thereafter, of the rudder trim tab control rod at the bend radius for possible cracks and for excessive wear of the rod at the bearing surface of the rod and the rudder trim tab screw. Inspection of the bend radius of the rudder trim tab control shall be performed with a magnifying lens of at least 10 power. Cracked or excessively worn rudder trim tab control rods shall be replaced prior to further flight.
