Piper Aircraft Corporation

# SERVICE LETTER

No. 420A

Subject: Removal of Vanes from Throat of Carburetor Air Box

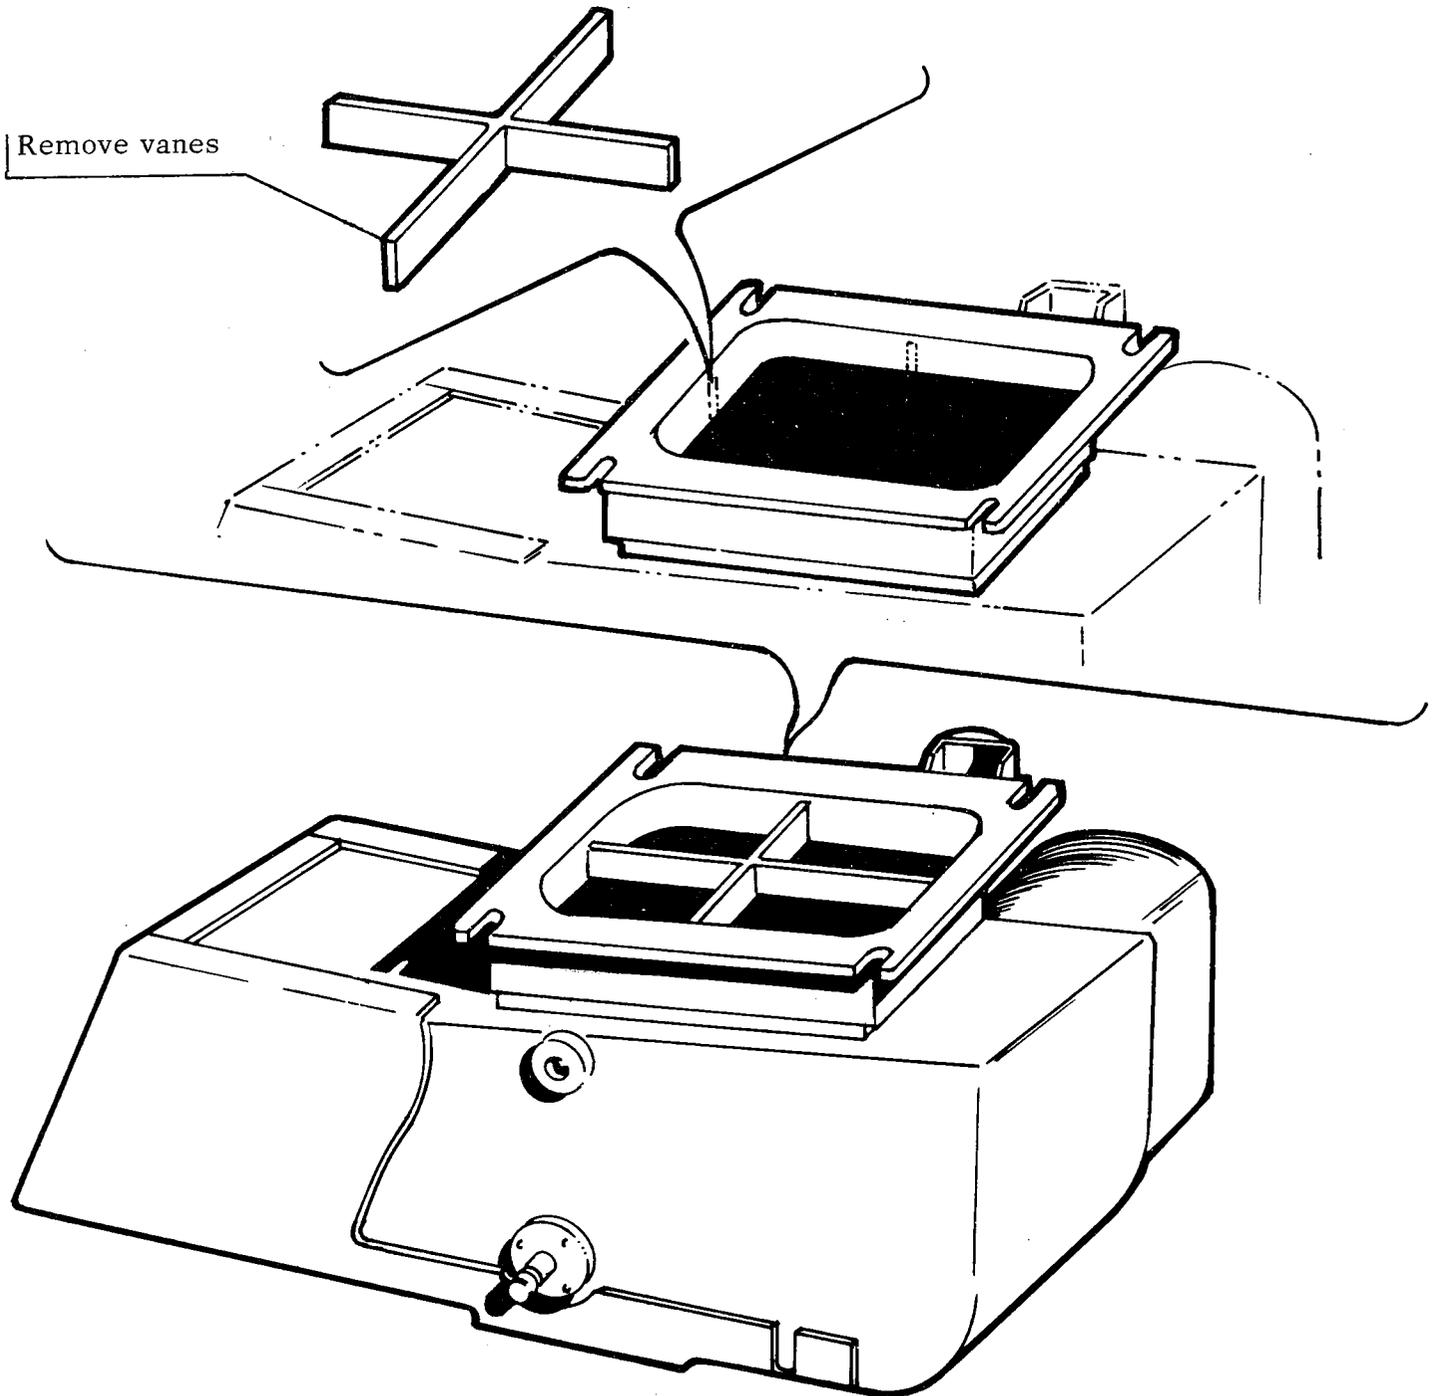
"A few reports have been received by the Service Department indicating that cracks have occurred in the vanes located in the throat of the carburetor air box, part number 21943-03. There have also been a few instances where a piece of the vane has broken off and lodged in the carburetor, causing a reduction in engine power.

The vanes may be removed in the following manner

Refer to the sketch on page 3 of this Service Letter for information and instructions concerning the removal of the vanes.

Contained on the sketch on page 3 of this Service Letter.

1. Remove the carburetor air scoop assembly.
2. Remove the carburetor air filter.
3. Remove the clamp at the carburetor air box end of the carburetor air filter coupling. Compress the coupling and lay it on the top of the box.
4. With a blunt bladed tool, such as a wide blade screw driver (do not use a chisel), gently tap each side of the vanes at the welded attachment point until it breaks loose from the air box throat. (Due to the softness of the metal vanes they will generally break clean. However, be certain that there are no ragged edges left in the throat and that all particles of metal have been removed from the area.)
