SERVICE LETTER

No. 675

Piper Aircraft Corporation

Magneto Switch Guard Installation

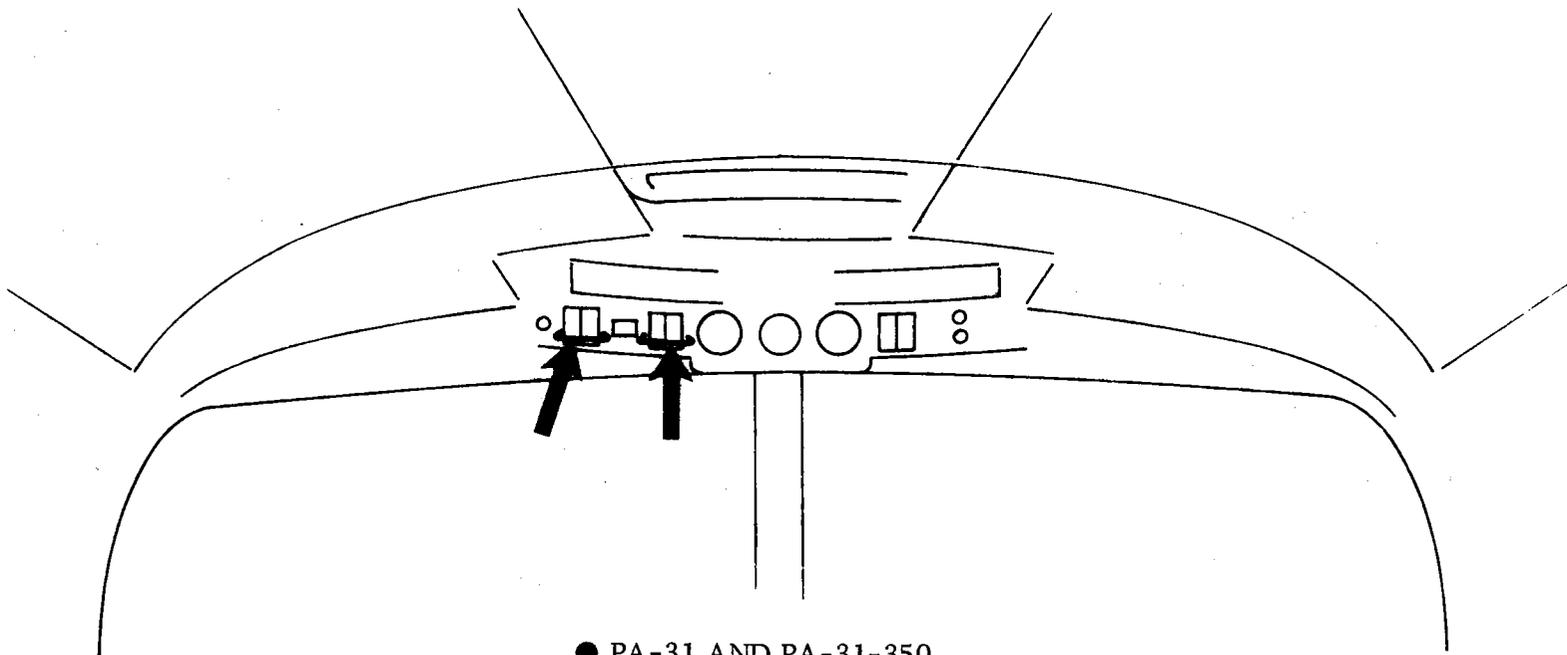
● PA-31 AND PA-31-350

The magneto switches on the Navajo Series aircraft are located on the overhead instrument panel and are "rocker" type switches. Installation of the subject switch guards will assist in preventing inadvertent magneto switch shut-off. Refer to sketch on reverse side of this letter for a general illustration of the switch guard installation.

1. PA-31 and PA-31-300 Navajos and PA-31-350 Navajo Chieftain -- reference Serial Numbers Affected, above; one (1) each per aircraft Magneto Switch Guard Installation Kit, Piper Part No. 760 789, at \$3.76A suggested retail unit price.
2. PA-31P Navajo -- reference Serial Numbers Affected, above; one (1) each per aircraft Magneto Switch Guard Installation Kit, Piper Part No. 760 790 at \$1.94A suggested retail unit price.
