# SERVICE No. 1041 BULLETIN

**Distribution of Airborne Service Letter Number 56,  
“Inspection and Cleaning of Airborne Air Filter Elements”**

**Service Letter Number:** 56

**Subject:** Inspection and Cleaning of Airborne Air Filter Elements.

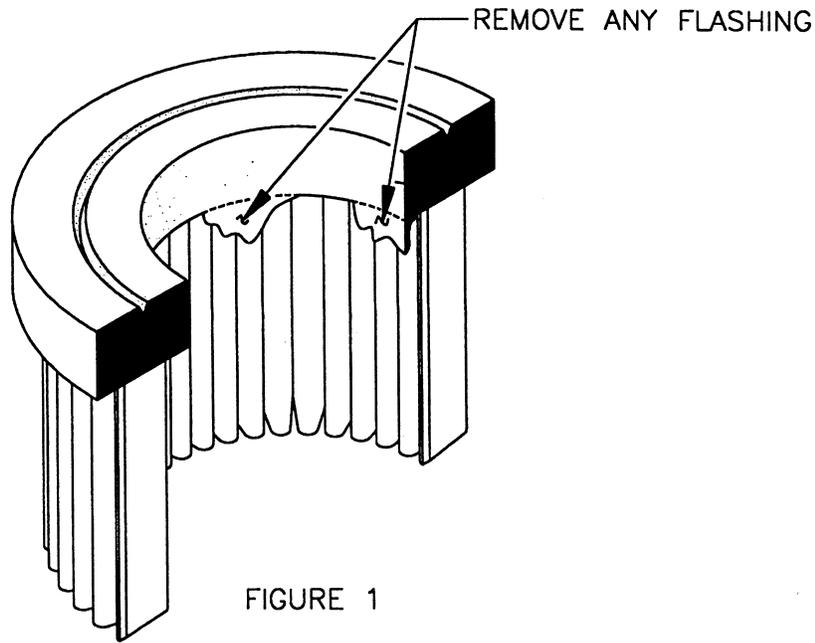
- 1) Remove the affected air filter element from aircraft per the instructions outlined in the appropriate maintenance/service manual provided by the airframe manufacturer.
- 2) Inspect the inner diameter of the black end piece(s) of these elements for flashing (Figure 1). Remove all flashing using a sharp knife. Caution: Do not cut the paper filter portion of the element.

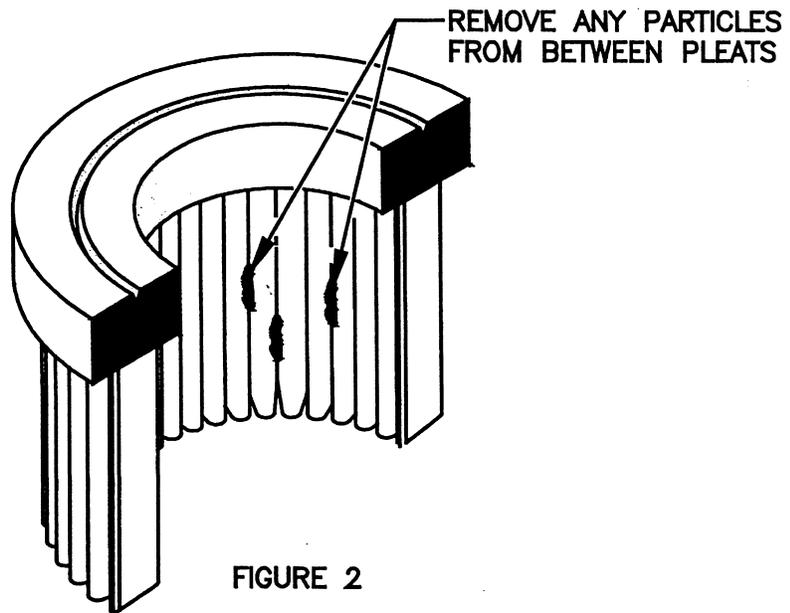
- 3) Tap the element lightly on a clean work surface in order to remove any loose particles from between the pleat tips on the inside of the paper filter (Figure 2).

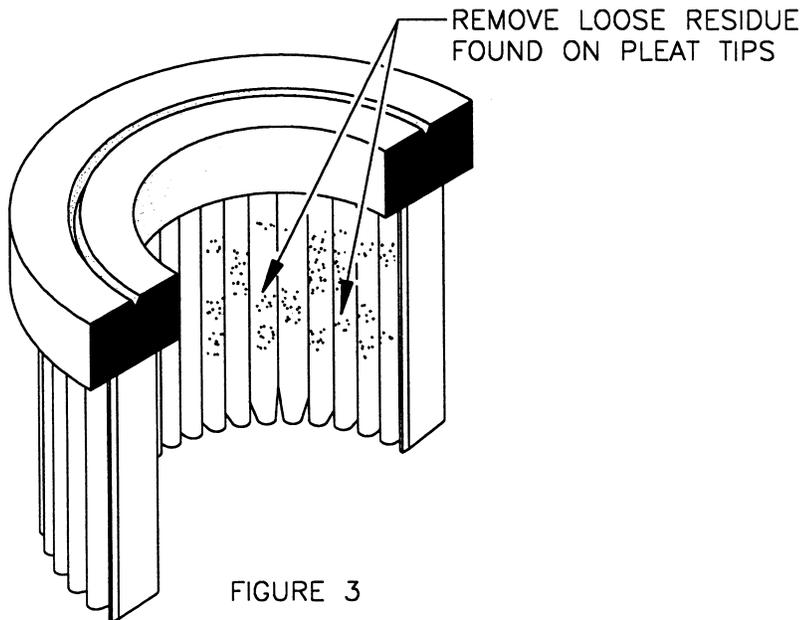
- 4) Inspect the inner diameter (pleat tips) of the paper filter for black residue (Figure 3). Remove all loose residue using the "sticky side" of a strip of masking tape attached to the end of a blunt instrument.

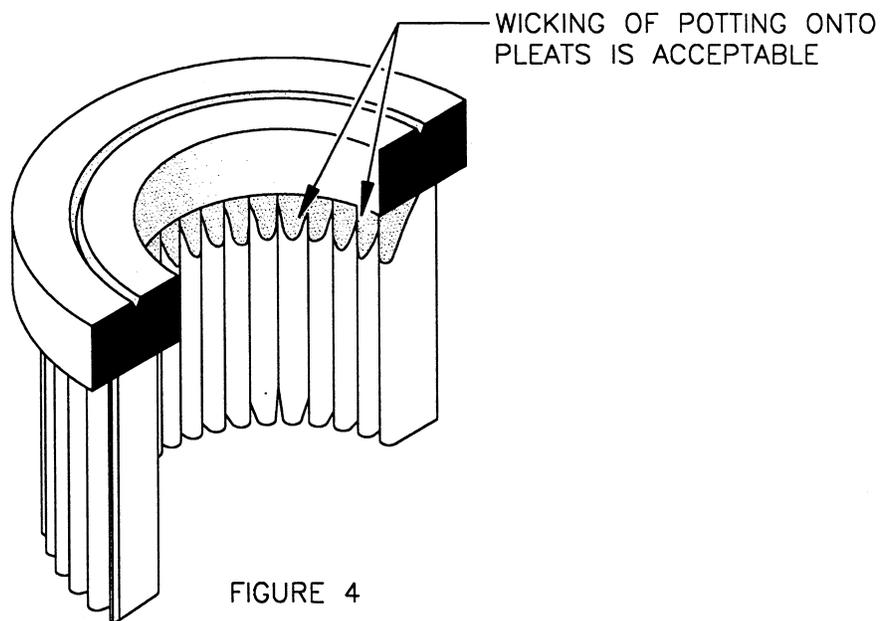
- 6) Thoroughly inspect all internal surfaces of the element for any loose particles. Remove any remaining loose particles using any combination of the above steps. Note: The wicking of black potting material onto pleats of paper filter is acceptable (Figure 4).
