Service Letter No. 432

SUBJECT: Inspection of Auxiliary Power Plug Solenoid

MODELS AFFECTED: PA-23-250 (6 place) Aztecs - Serials 27-2420, 27-2422, 27-2434, 27-2439, 27-2455, 27-2460, 27-2472, 27-2486, 27-2491, 27-2493, 27-2502, 27-2511 to 27-2515 incl., 27-2517, 27-2519 to 27-2522 incl., 27-2524, 27-2531, 27-2533, 27-2534, 27-2538, 27-2542, 27-2544, 27-2546, 27-2550, 27-2554 to 27-2560 incl., 27-2563.

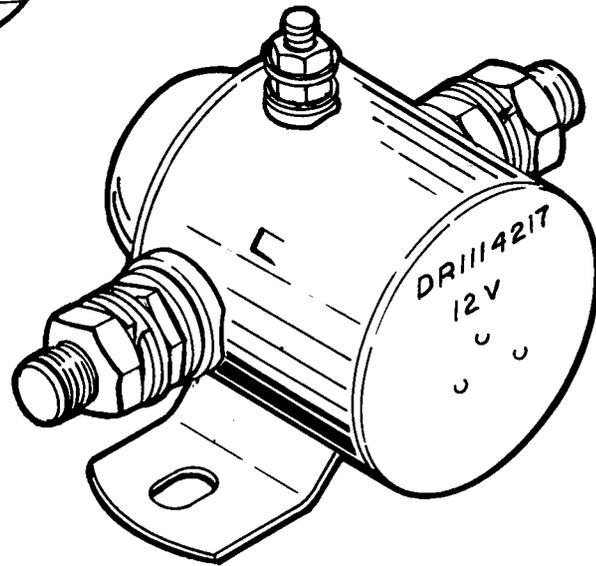
*Service Letter
No. 432*

It is possible that the solenoid used in the auxiliary power plug installation in the above aircraft may be the wrong type. The solenoid may be identified by a part number stamped on the bottom. See sketch on the reverse side of this letter.

A solenoid with part number 001464 at this point should be replaced with Piper part number 487 153 (1114217).
