VSP-30  
May 20, 1981

VENDOR SERVICE PUBLICATION

Subject: Bendix Service Bulletins 599A, 609A, 610,  
613, 614

**SERVICE BULLETIN NO. 599A**  
(Supersedes Service Bulletin No. 599)  
Engineering Aspects are  
FAA Approved

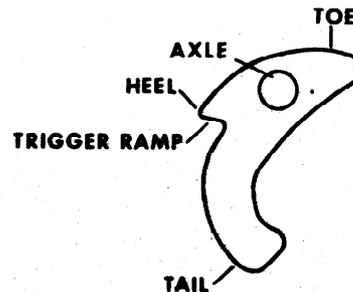
Figure 1. Terminology

- a. Bend the end of a stiff wire into a right angle 1/8 inch long, maximum.
- b. Position impulse coupling so that heel of flyweight (see figure 1) is adjacent to stop pin. Reach

between cam and flyweight with bent wire, as near as possible to the stop pin, and pull outward on the flyweight as shown in figure 2.

d. If less than 0.017 inch clearance exists, this is cause for immediate rejection of the impulse coupling cam assembly, or possibly the entire impulse coupling. Refer to the applicable Magneto Overhaul Instructions for inspection procedures to determine if other impulse coupling parts are still serviceable.

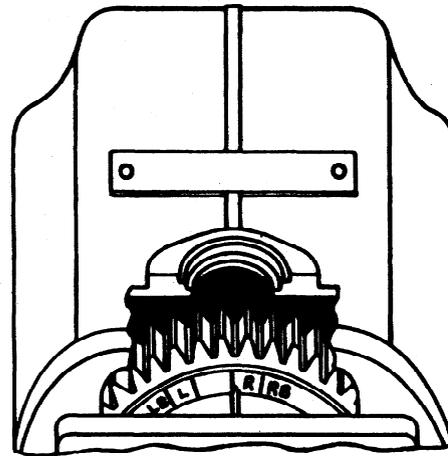
Figure 3. Alignment of Timing Marks on Distributor Gear – 6 Cylinder, Single Breaker, Right Hand Rotation

- b. "6" Cylinder, single breaker types – The timing rib on the distributor block MUST lie between the "L" and "LB" or the "R" and "RB" marks on the gear, and should be nearer to the "L" or "R" mark, depending on magneto rotation. (See figure 3)

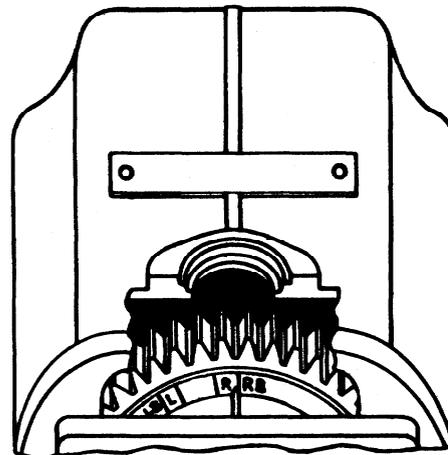
Figure 4. Alignment of Timing Mark on Distributor Gear – 6 Cylinder, Retard Breaker, Right Hand Rotation

- c. "6" Cylinder, retard breaker types – The timing rib on distributor block MUST lie between the "L" and "LB" or the "R" and "RB" marks on the gear, and should be nearer to the "LB" or "RB" mark, depending on magneto rotation. (See figure 4)

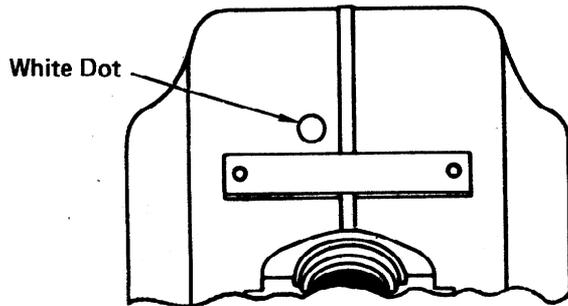
Figure 5. Typical identification mark location.

- a. An appropriate Engine Log Book entry must be made.
- b. The magneto must be identified by painting a white dot approximately 1/4 inch in diameter on the magneto housing at the location indicated in figure 5.

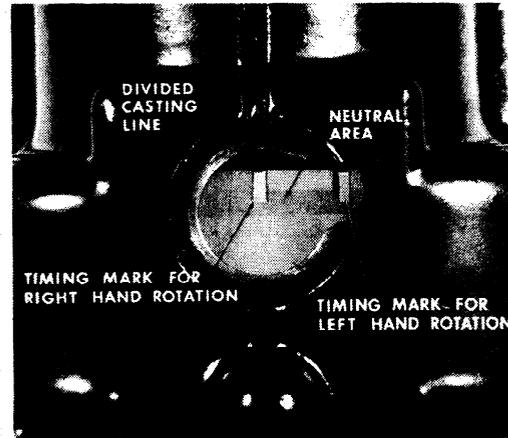
Figure 2. Alignment of Magnet Marks – Right Hand Rotation

b. Continue turning the engine slowly, still in the direction of normal rotation, until the proper timing mark on the rotating magnet is centered in the viewing hole. Figure 2 illustrates the timing mark centered for a right hand rotation magneto. A left hand rotation magneto would have the left hand mark centered. (See figure 2.) Eight cylinder magnetos will show an "R" line or an "L" line on the rotating magnet.

one cylinder firing position until proper timing mark on rotating magnet is in the center of the viewing hole. (See figure 2.)

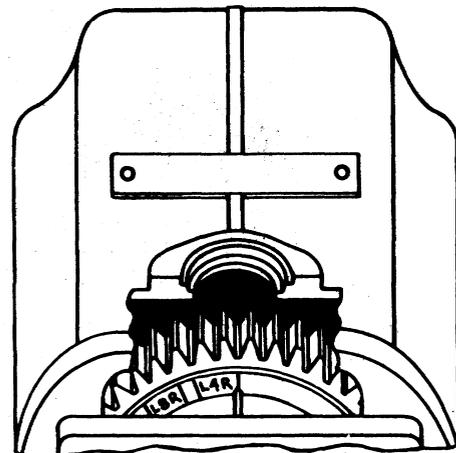
Figure 3. Alignment of Timing Marks on Distributor Gear – 4 Cylinder, Right Hand Rotation

a. Four and eight cylinder, all types – The timing rib on the distributor block **MUST** align within 1/2 tooth either side of the "L" or "R" mark on the gear, depending on magneto rotation. (See figure 3.)

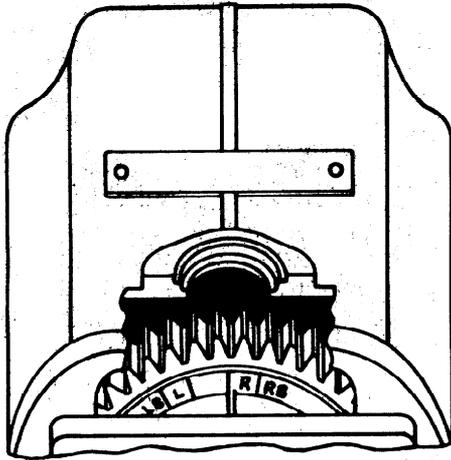
Figure 4. Alignment of Timing Marks on Distributor Gear — 6 Cylinder, Single Breaker, Right Hand Rotation

b. Six cylinder, single breaker types — The timing rib on the distributor block **MUST** lie between the "L" and "LB" or the "R" and "RB" marks on the gear, and should be nearer to the "L" or "R" mark, depending on magneto rotation. See figure 4.

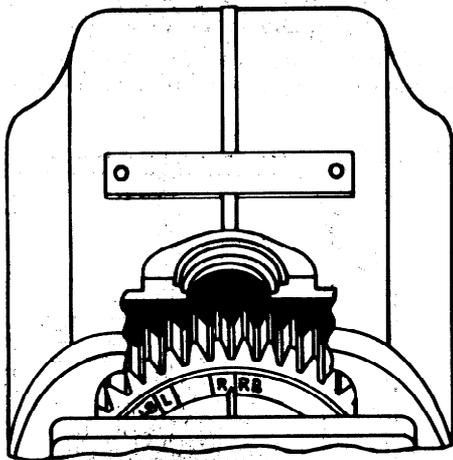
Figure 5. Alignment of Timing Marks on Distributor Gear — 6 Cylinder, Retard Breaker, Right Hand Rotation

c. Six cylinder, retard breaker types — The timing rib on the distributor block **MUST** lie between the "L" and "LB" or the "R" and "RB" marks on the gear, and should be nearer to the "LB" or "RB" mark, depending on magneto rotation. (See figure 5.)
