# SERVICE BULLETIN

No. 464A

Piper Aircraft Corporation

Subject: Inspection of Stabilator Torque Tube Bearing Block Attachment Fitting Rivets.

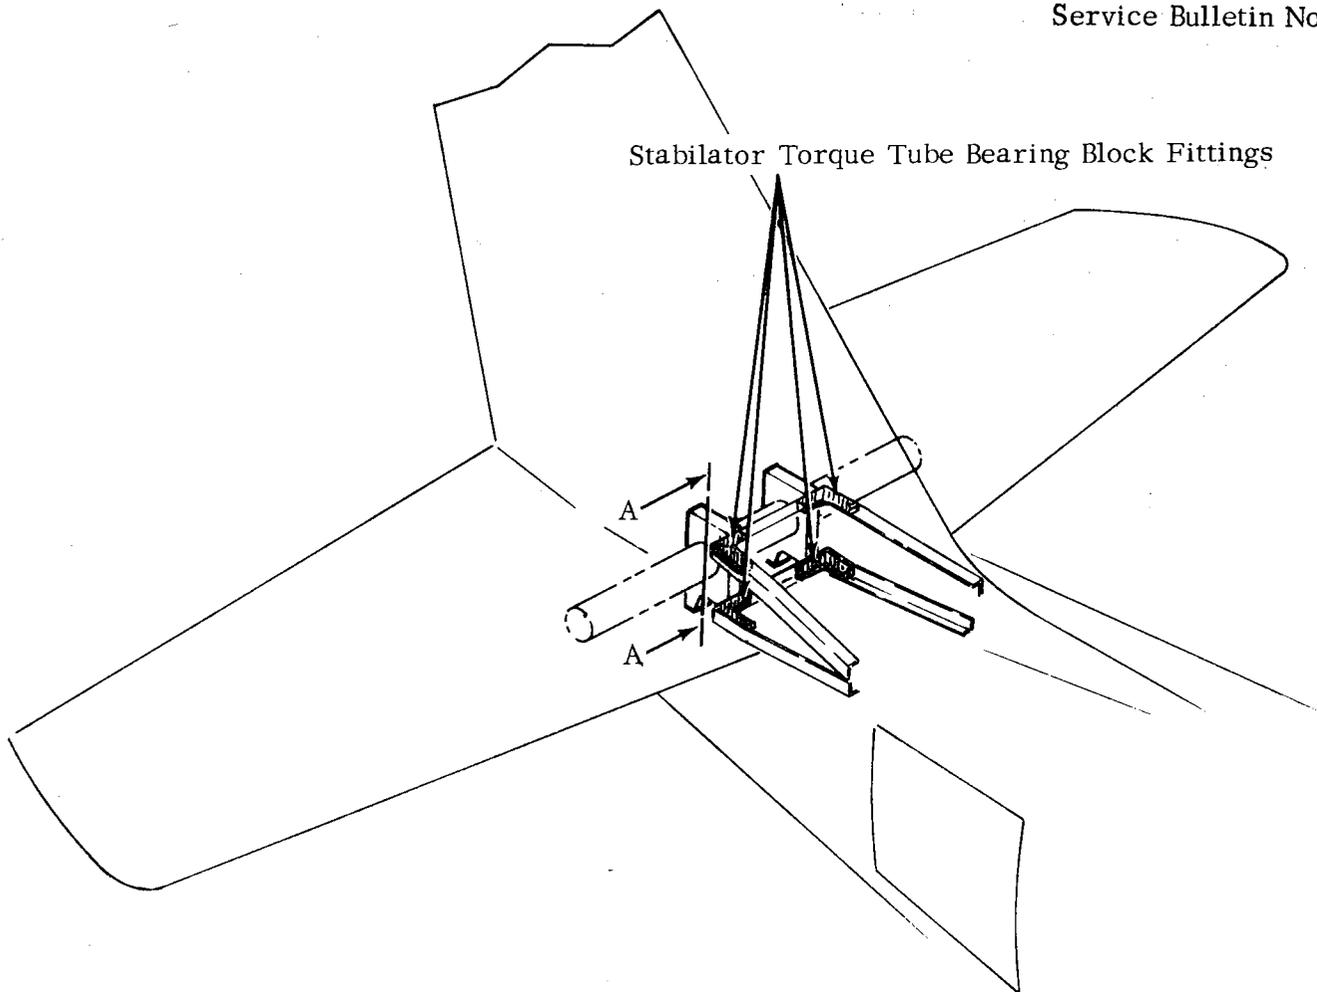
Stabilator Bearing Block Attachment Fitting Rivets (see sketch for an illustration of this condition).

A study was conducted to determine the significance of the above described condition. It was subsequently determined that the rear corner rivet in the bearing block fitting (which is most susceptible to drill penetration) is redundant to the structural integrity of the fitting assembly, and also that one additional rivet located in the bearing block could be removed without reducing the strength of the assembly below an acceptable value. However, if more than two rivets per fitting (described above) have been penetrated during the drilling operation, it will be necessary to install one (1) each per fitting Piper Kit Number 760 835, Hi Shear Rivet Replacement, and install bolts (per kit instructions) in place of the existing rivets in those bearing blocks which contain more than two rivets penetrated during drilling.

1. One (1) each PER FITTING (i.e., each kit contains sufficient material to modify one only Stabilator Torque Tube Bearing Block Fitting), Piper Kit Number 760 835, Hi Shear Rivet Replacement, if required per Instructions number 3, above.
2. Two (2) each per aircraft Cover Plate, Part Number 28216-02, if installation of Kit 760 835 is required per Instructions number 3, above.
