SERVICE LETTER

No. 556A

Piper Aircraft Corporation

Subject: Turbocharger Waste Gate Return Spring

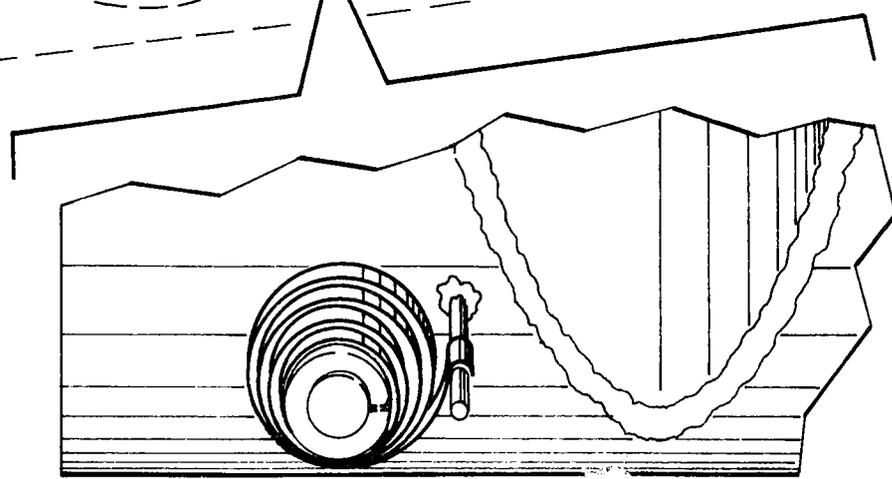
Purpose: To replace the existing turbocharger waste gate return spring with a new heavy duty return spring.

1. Pull turbocharger controls to the OFF position.
2. With side and bottom cowl panels removed, remove the existing turbocharger waste gate spring.
3. Install new turbocharger waste gate spring, RaJay Part Number RJ4120-11, being careful to install center tang in hole 180° to hole from which old spring was removed.
4. Place turbocharger waste gate spring on spring retainer as shown.
5. Actuate turbocharger controls to determine spring winds and unwinds freely.
6. Reinstall cowl.
