SERVICE BULLETIN

No. 739

Piper Aircraft Corporation

Subject: Restriction of Flap Travel and Inspection of Wing Flap Flexible Drive Shaft

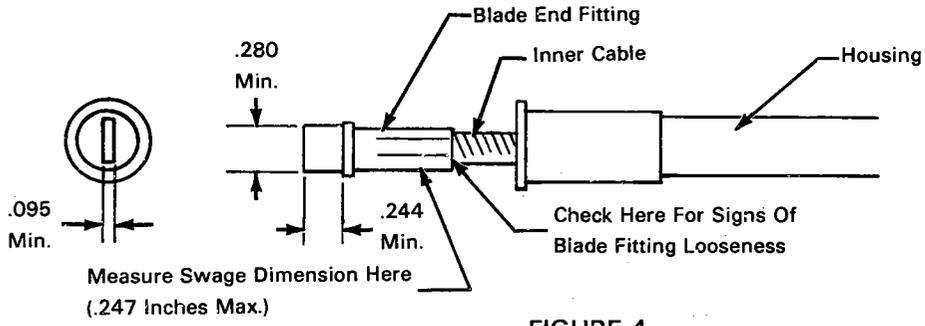
SKETCH D

5. Inspect the swaged fittings at both ends of the flexible shaft as follows:
 - a. Expose the swaged portion of the inner cable at the motor end by twisting the outer housing two (2) turns clockwise. The swaged portion of the cable should have six (6) or eight (8) flats clearly visible and free from deep scratches or wear marks. (Ref. Sketch D, Figure 2.).

- b. Using a micrometer, or dial caliper, measure the diameter of the swage for each of the flats at the middle of the swaged portion of the cable. A total of three (3) measurements should be taken for the six (6) sided swage and a total of four (4) measurements should be taken for the eight (8) sided swage. If any of the measurements exceed .235 inch for the six (6) sided cable or .247 inch for the eight (8) sided cable, replace the drive shaft.

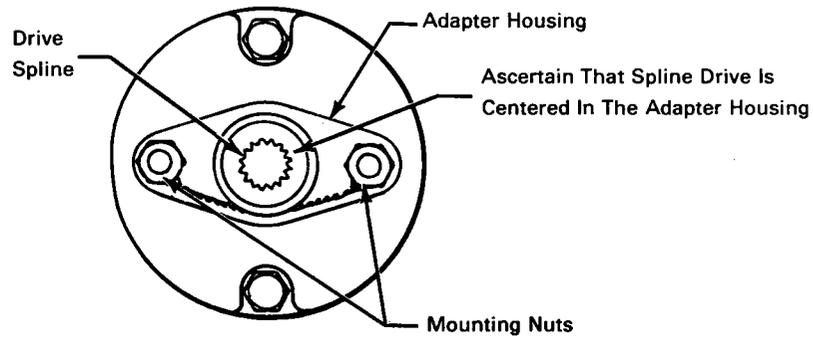
SKETCH E

- c. Disconnect drive shaft from the flap transmission. Using caution not to damage the shaft housing, route inboard through the Sta. 87.50 bulkhead. (ref Sketch E.) Inspect the swaged portion of the drive blade fitting end as described in "a" and "b" above.

- d. Inspect the drive blade dimension as shown in Sketch E, Figure 4.
