SERVICE No. 1008 BULLETIN

Date: September 30, 1997 (M)

Elevator Butt Rib Refinement

PA-31, 31-300, 31-325 Navajo
PA-31-350 Navajo Chieftain
PA-31-350 T1020
PA-31P-350 Mojave

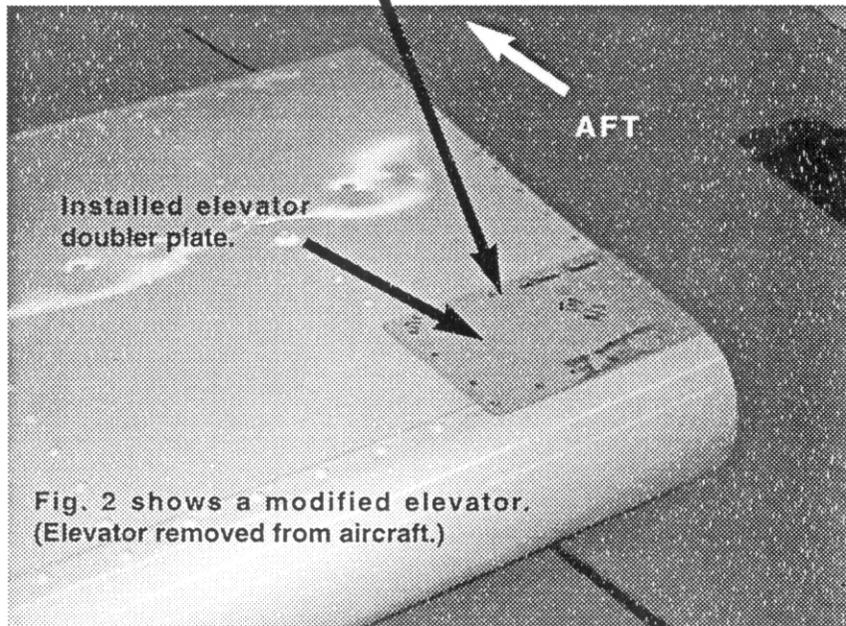
Approximate location of doubler plate on left and right elevators. Installation of doubler plate indicates the installation of the Elevator Butt Rib Refinement Kit p/n 766-642.
