Service Letter No. 280

SUBJECT: Rerouting of Engine Breather and Oil Separator Discharge Lines

MODEL AFFECTED: PA-23 Serials 23-1 to 23-746 inclusive

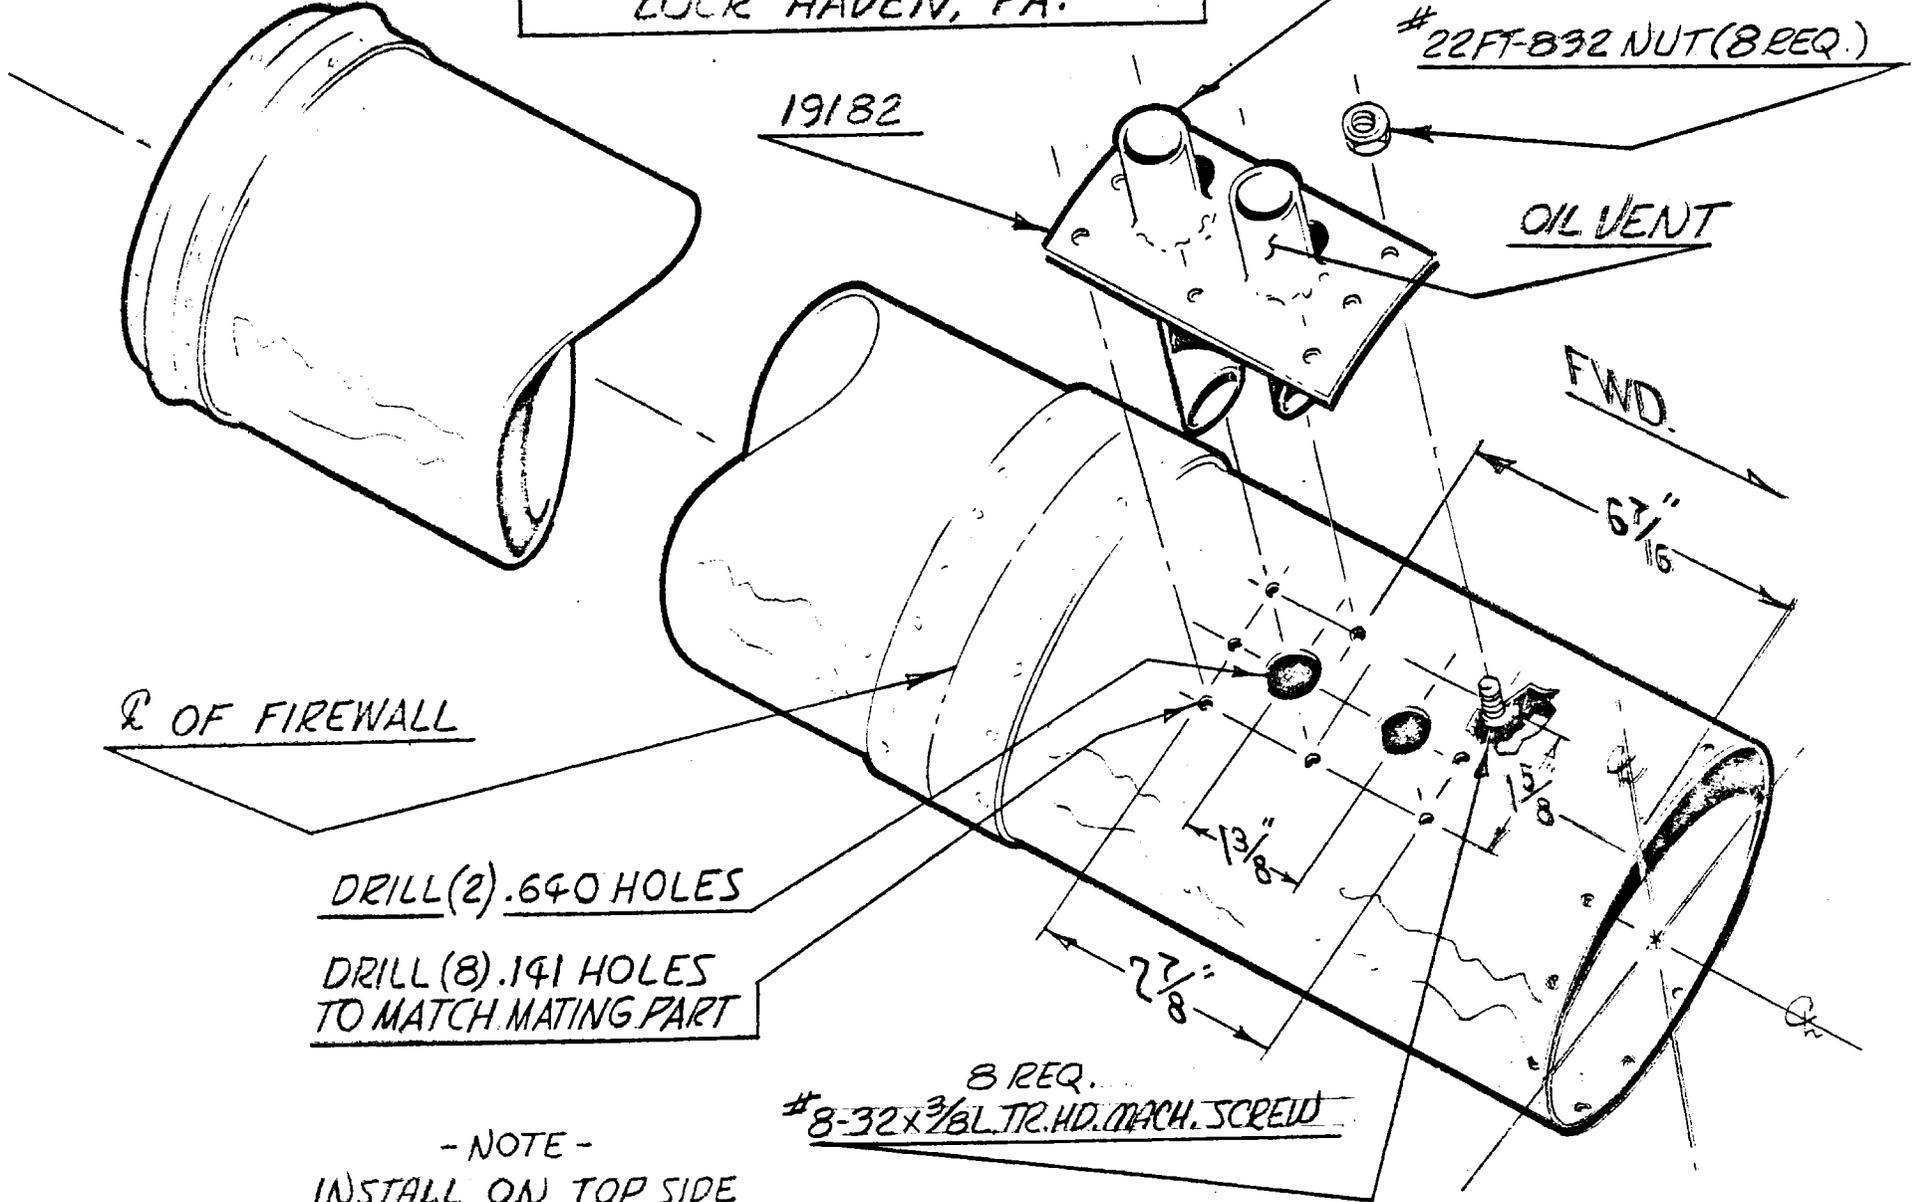
OIL & VACUUM DISCHARGE (PA23)	
SER. LETTER	# 280
PIPER AIRCRAFT CORP.	
LOCK HAVEN, PA.

OIL SEPARATOR

22 FF-832 NUT (8 REQ.)

19182

OIL VENT

DRILL (2) .640 HOLES

DRILL (8) .141 HOLES TO MATCH MATING PART

8 REQ.
8-32 x 3/8" L. TR. HD. MACH. SCREW

- NOTE -
INSTALL ON TOP SIDE OF AUGMENTOR TUBE

The engine breather lines and oil separator discharge lines that originally drained into the engine bottom cowl have been rerouted in later airplanes to drain into the engine exhaust ejector tubes. This modification can be performed on earlier model airplanes by rerouting the present lines, installing tube assembly, part number 19182-00, per sketch on the reverse side of this letter, and connecting the lines to the tube assembly with flexible rubber hose.

This tube assembly, part number 19182-00, can be ordered through your nearest Piper distributor or dealer at a list price of \$4.86. The flexible rubber hose can be procured locally.
