Service Letter No. 437

SUBJECT: Replacement of Fuel Gage Assembly

MODELS AFFECTED: PA-24-400 Comanches, Serial Numbers 26-2 to 26-60 incl., 26-65 to 26-69 incl., 26-71 to 26-79 incl., 26-82, 26-84 to 26-87 incl., 26-89, 26-90, 26-92 to 26-96 incl., 26-114, 26-123, 26-124

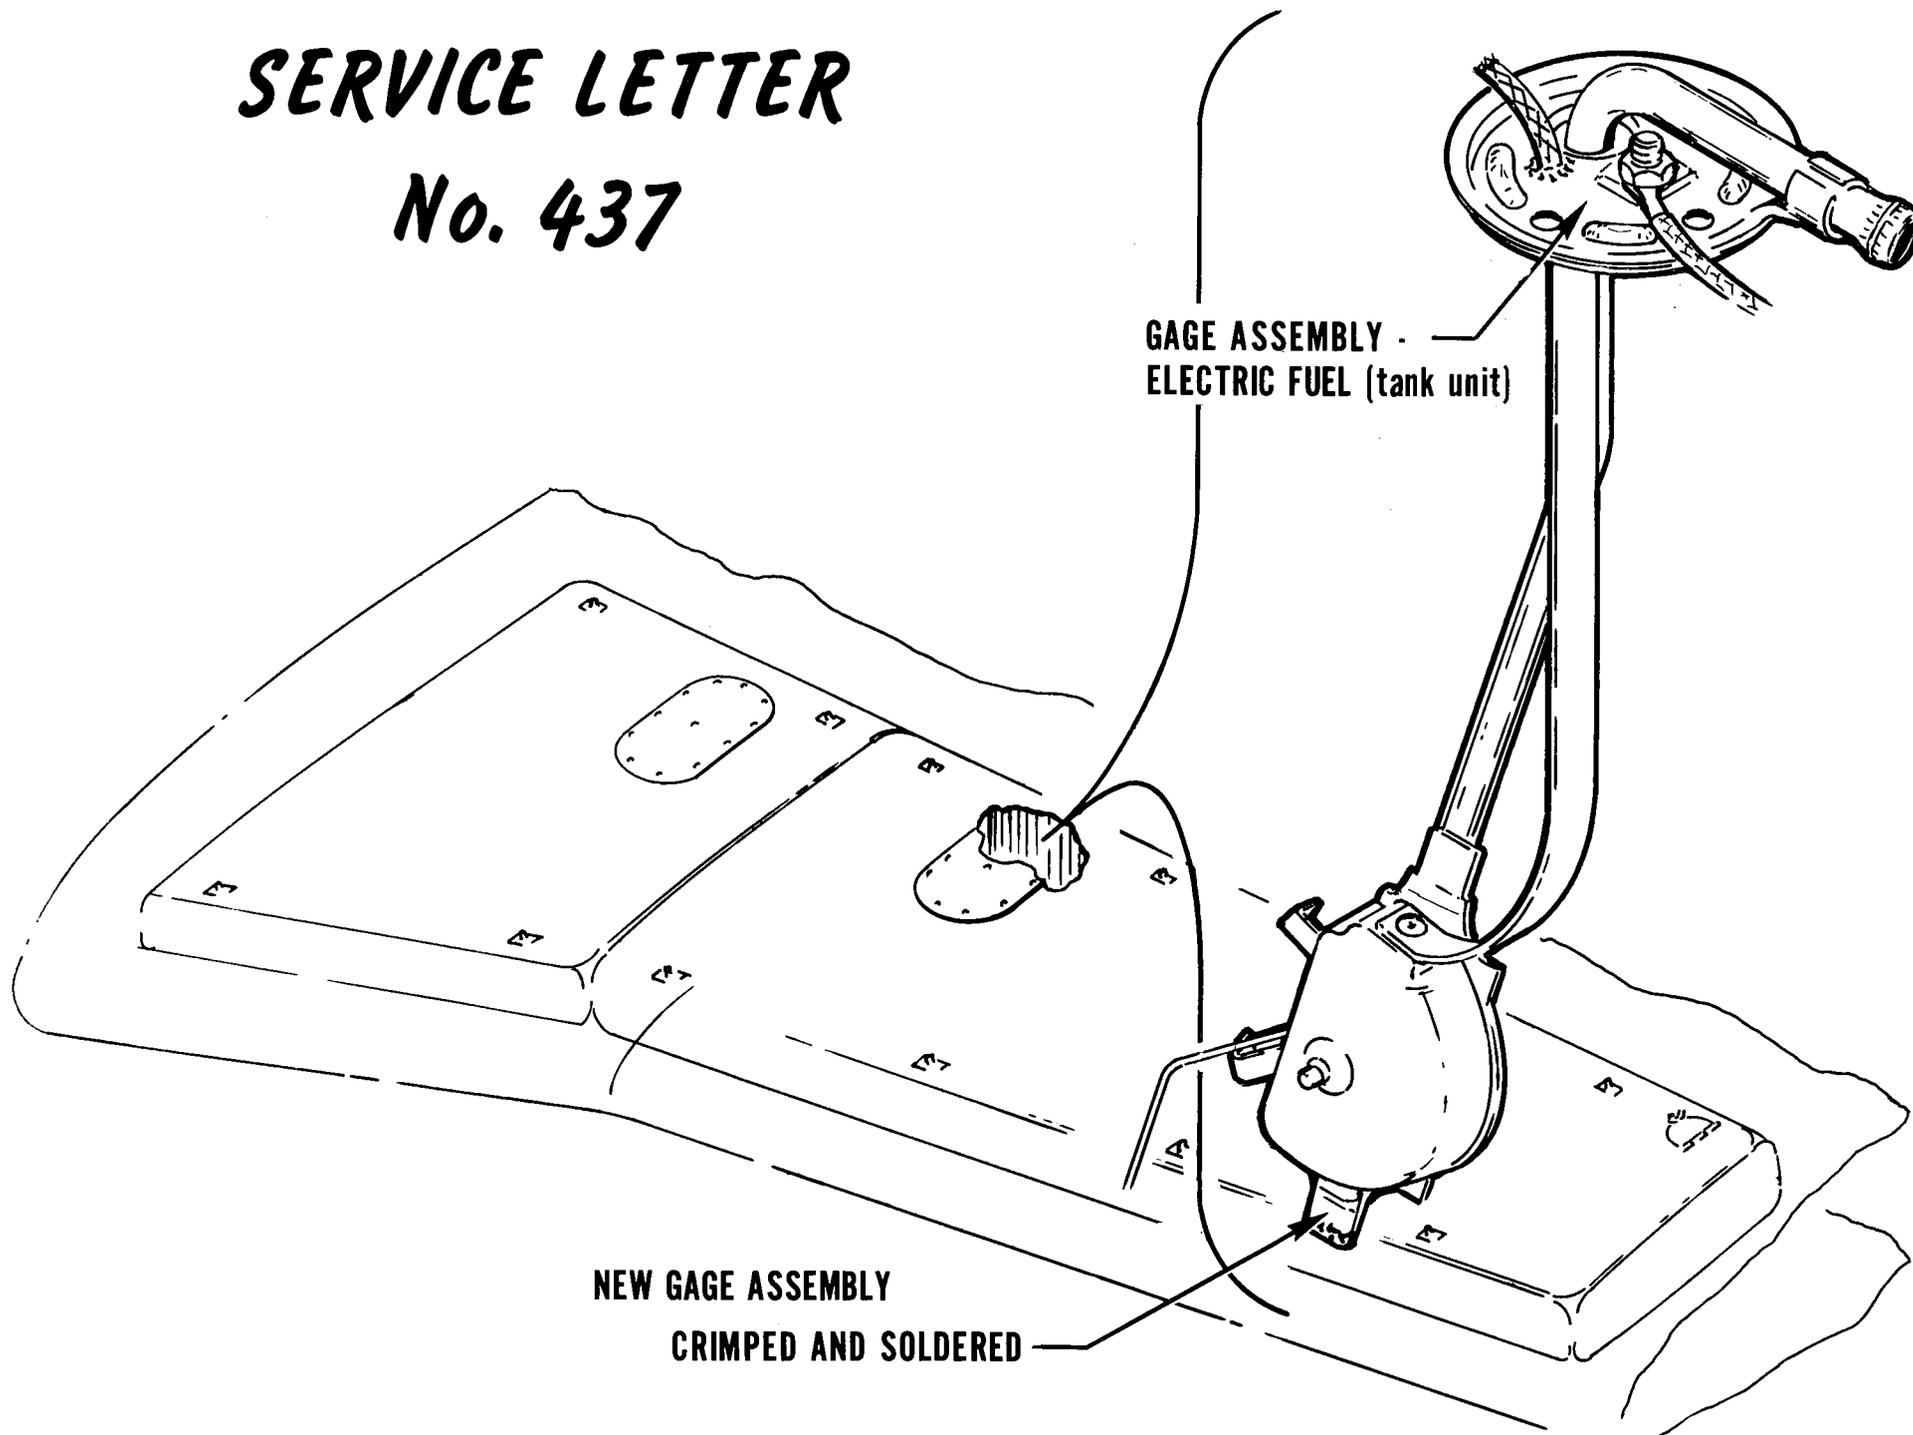
No. 437

Reports of corroded inboard fuel gage assemblies in the outboard fuel cell makes it necessary to replace this unit. See sketch on the reverse side of this letter for proper location of fuel gage assembly.

GAGE ASSEMBLY -
ELECTRIC FUEL (tank unit)

NEW GAGE ASSEMBLY
CRIMPED AND SOLDERED

Replacement fuel gage assemblies should be ordered under part number 450 771 (2 per airplane).
