# SERVICE <sup>No. 191</sup> BULLETIN

Piper Aircraft Corporation

**SUBJECT:** Aileron Hinge Bracket - Part No. 20211-00

**MODELS AFFECTED:** PA-24 and PA-24-250 Comanches  
Serial Nos. 24-1 to 24-1243 inclusive

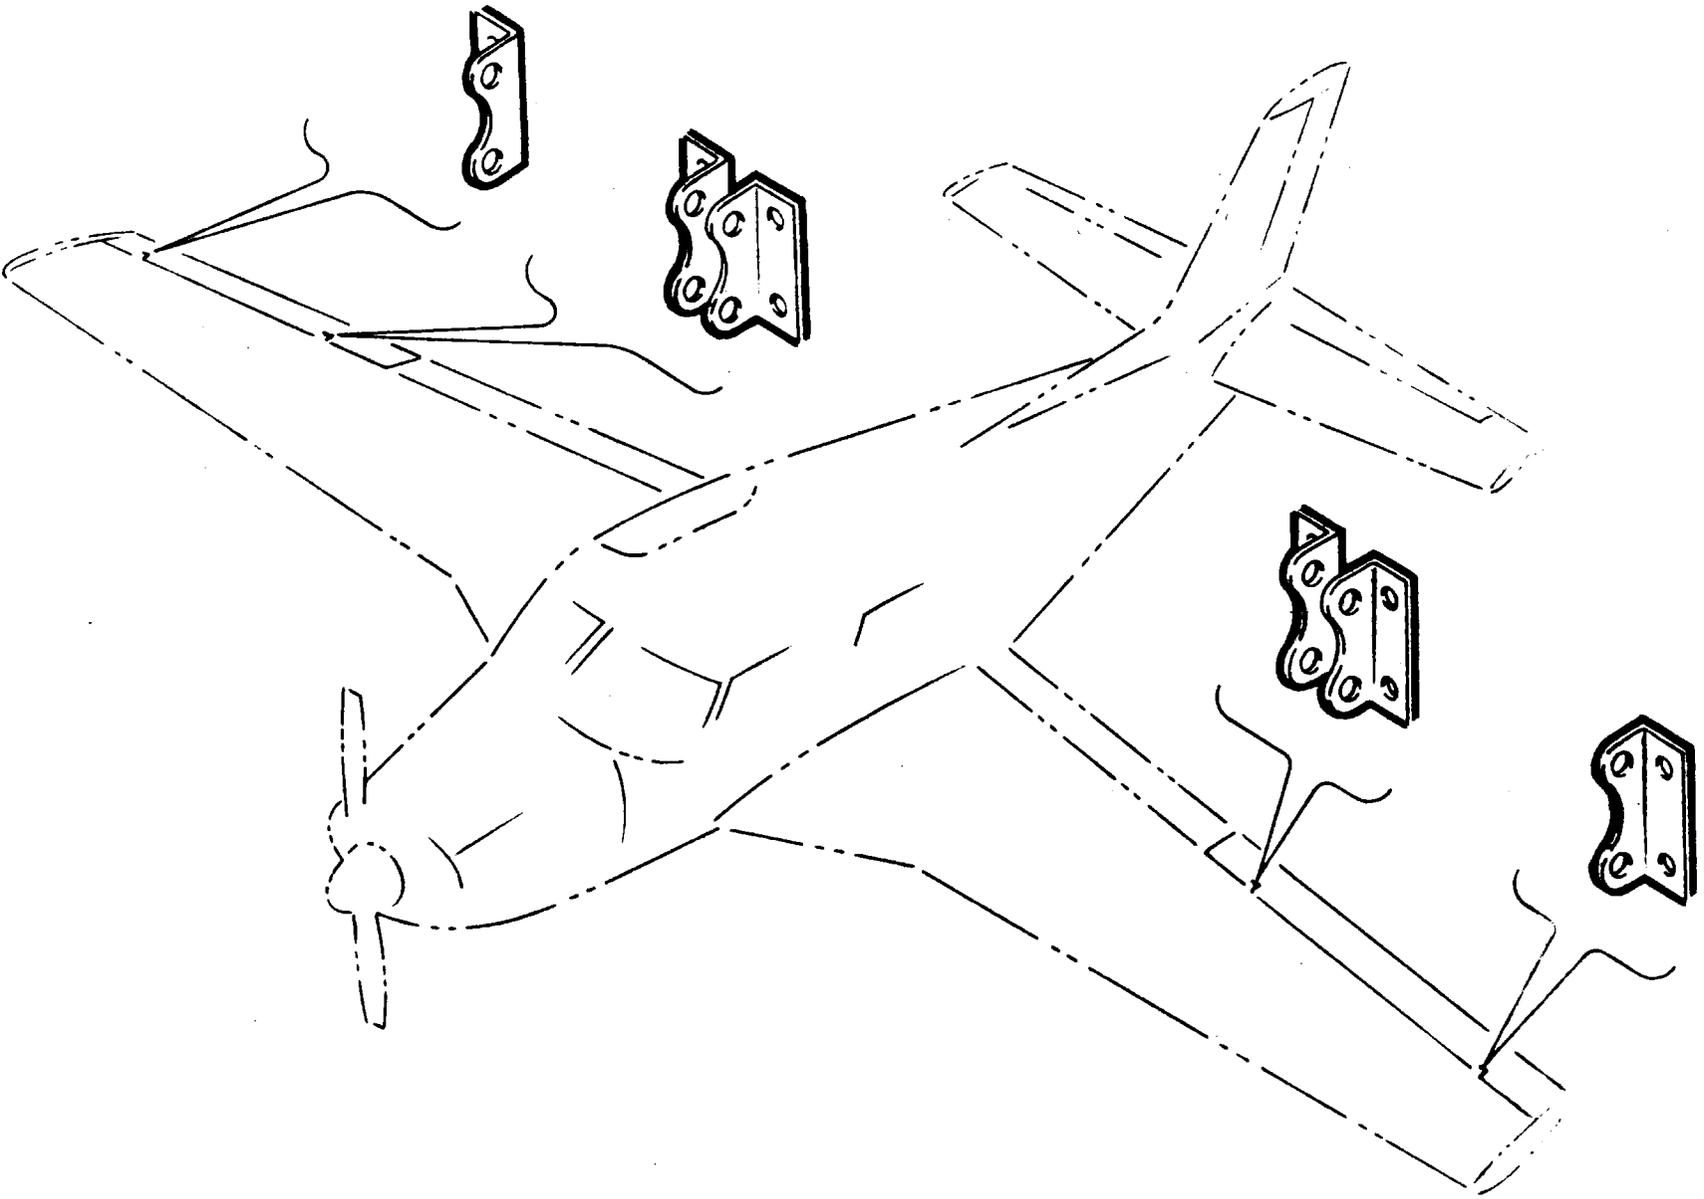
SERVICE BULLETIN 191

It has been brought to our attention in a recent report from the field that a crack was discovered in one of the subject aileron hinge brackets, part number 20211-00.

Reference to the sketch on the reverse side of this bulletin will indicate the location of these brackets.

This report is an isolated case, however, we feel that a visual inspection of these brackets should be made on all Comanches as indicated by the above serial numbers and any cracked brackets should be replaced.
