# SERVICE BULLETIN

No. 682

Piper Aircraft Corporation

Subject: Main Landing Gear Inboard Door Hinge  
Inspection/Replacement

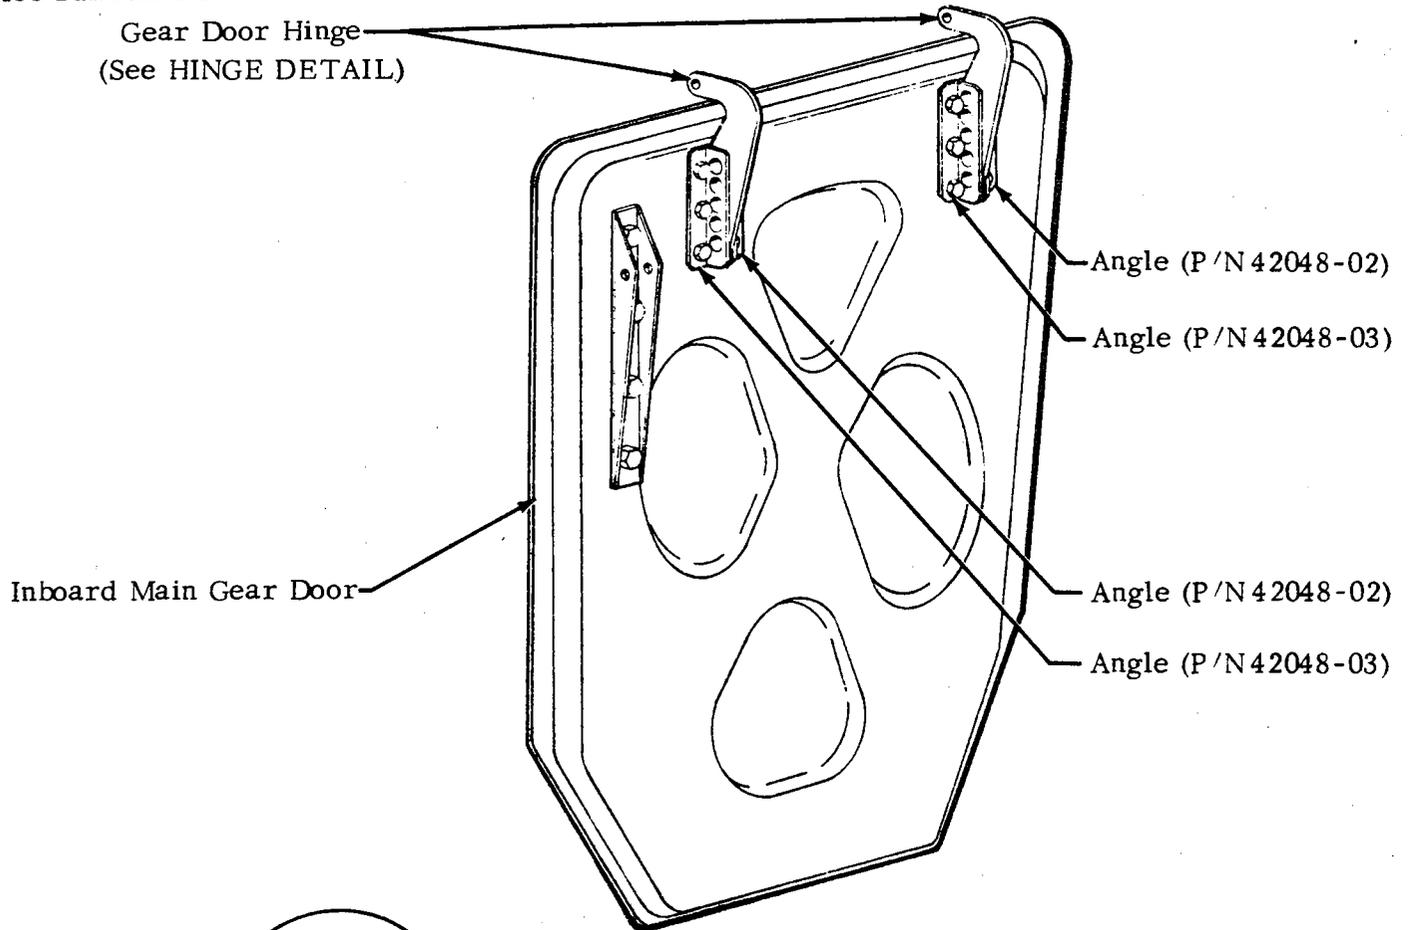
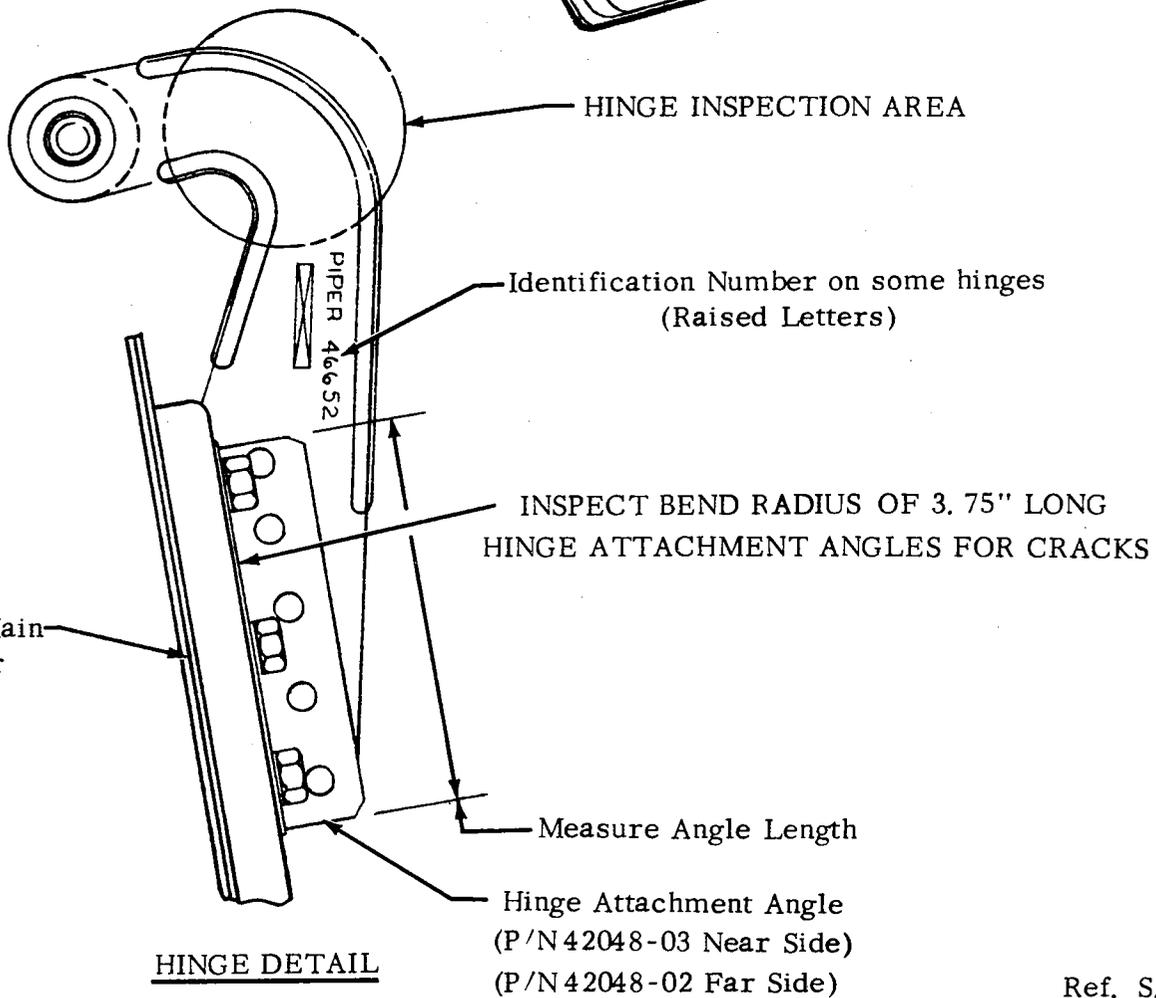
- a. One type is an aluminum forging which will have an identification number "PIPER 46652" as raised letters on the forging as shown on sketch. This type hinge requires inspection per step 3.

3. Inspect the aluminum inboard gear door hinges for cracks, in the area shown on sketch. Inspect for cracks using the Dye Penetrant Method. (All paint must be removed from the inspection area.)

4. Refer to sketch and measure the length of each hinge attachment angle (two on each hinge).
  - a. Hinge attachment angles which measure 4.00" long do not require inspection per step 5.
  - b. Hinge attachment angles which measure 3.75" long require inspection per step 5.
5. Inspect the 3.75" long hinge attachment angle(s), in the angle bend radius, for cracks. Inspect for cracks using the Dye Penetrant Method. (All paint must be removed from the inspection area.)

- a. All door hinges that are cracked must be replaced with a new improved door hinge assembly (P/N 47529-32) prior to further flight. If new improved door hinge assembly (P/N 47529-32) is not available as a replacement, a new original equipment hinge assembly (P/N 46653-00) may be installed.

NOTE: New improved door hinge assembly (P/N 47529-32) consists of a new hinge (forging identification with PIPER 46652-2 in raised letters) and two attachment angles (P/N 42048-02 and P/N 42048-03). Original equipment hinge assembly (P/N 46653-00) does not include the two attachment angles and has been made from an aluminum forging (Forging identified with PIPER 46652 in raised letters) or made from .250 sheet steel (with no identification number or made from .250 sheet aluminum (with no identification number)).

All hinge attachment angles that are cracked must be replaced with new angle(s) (P/N 42048-02 and/or P/N 42048-03) or by installing new improved door hinge assembly(ies) (P/N 47529-32), which include the angles, prior to further flight.
