SERVICE LETTER

No. 711

Piper Aircraft Corporation

Subject: Inspection of Submerged Fuel Pumps

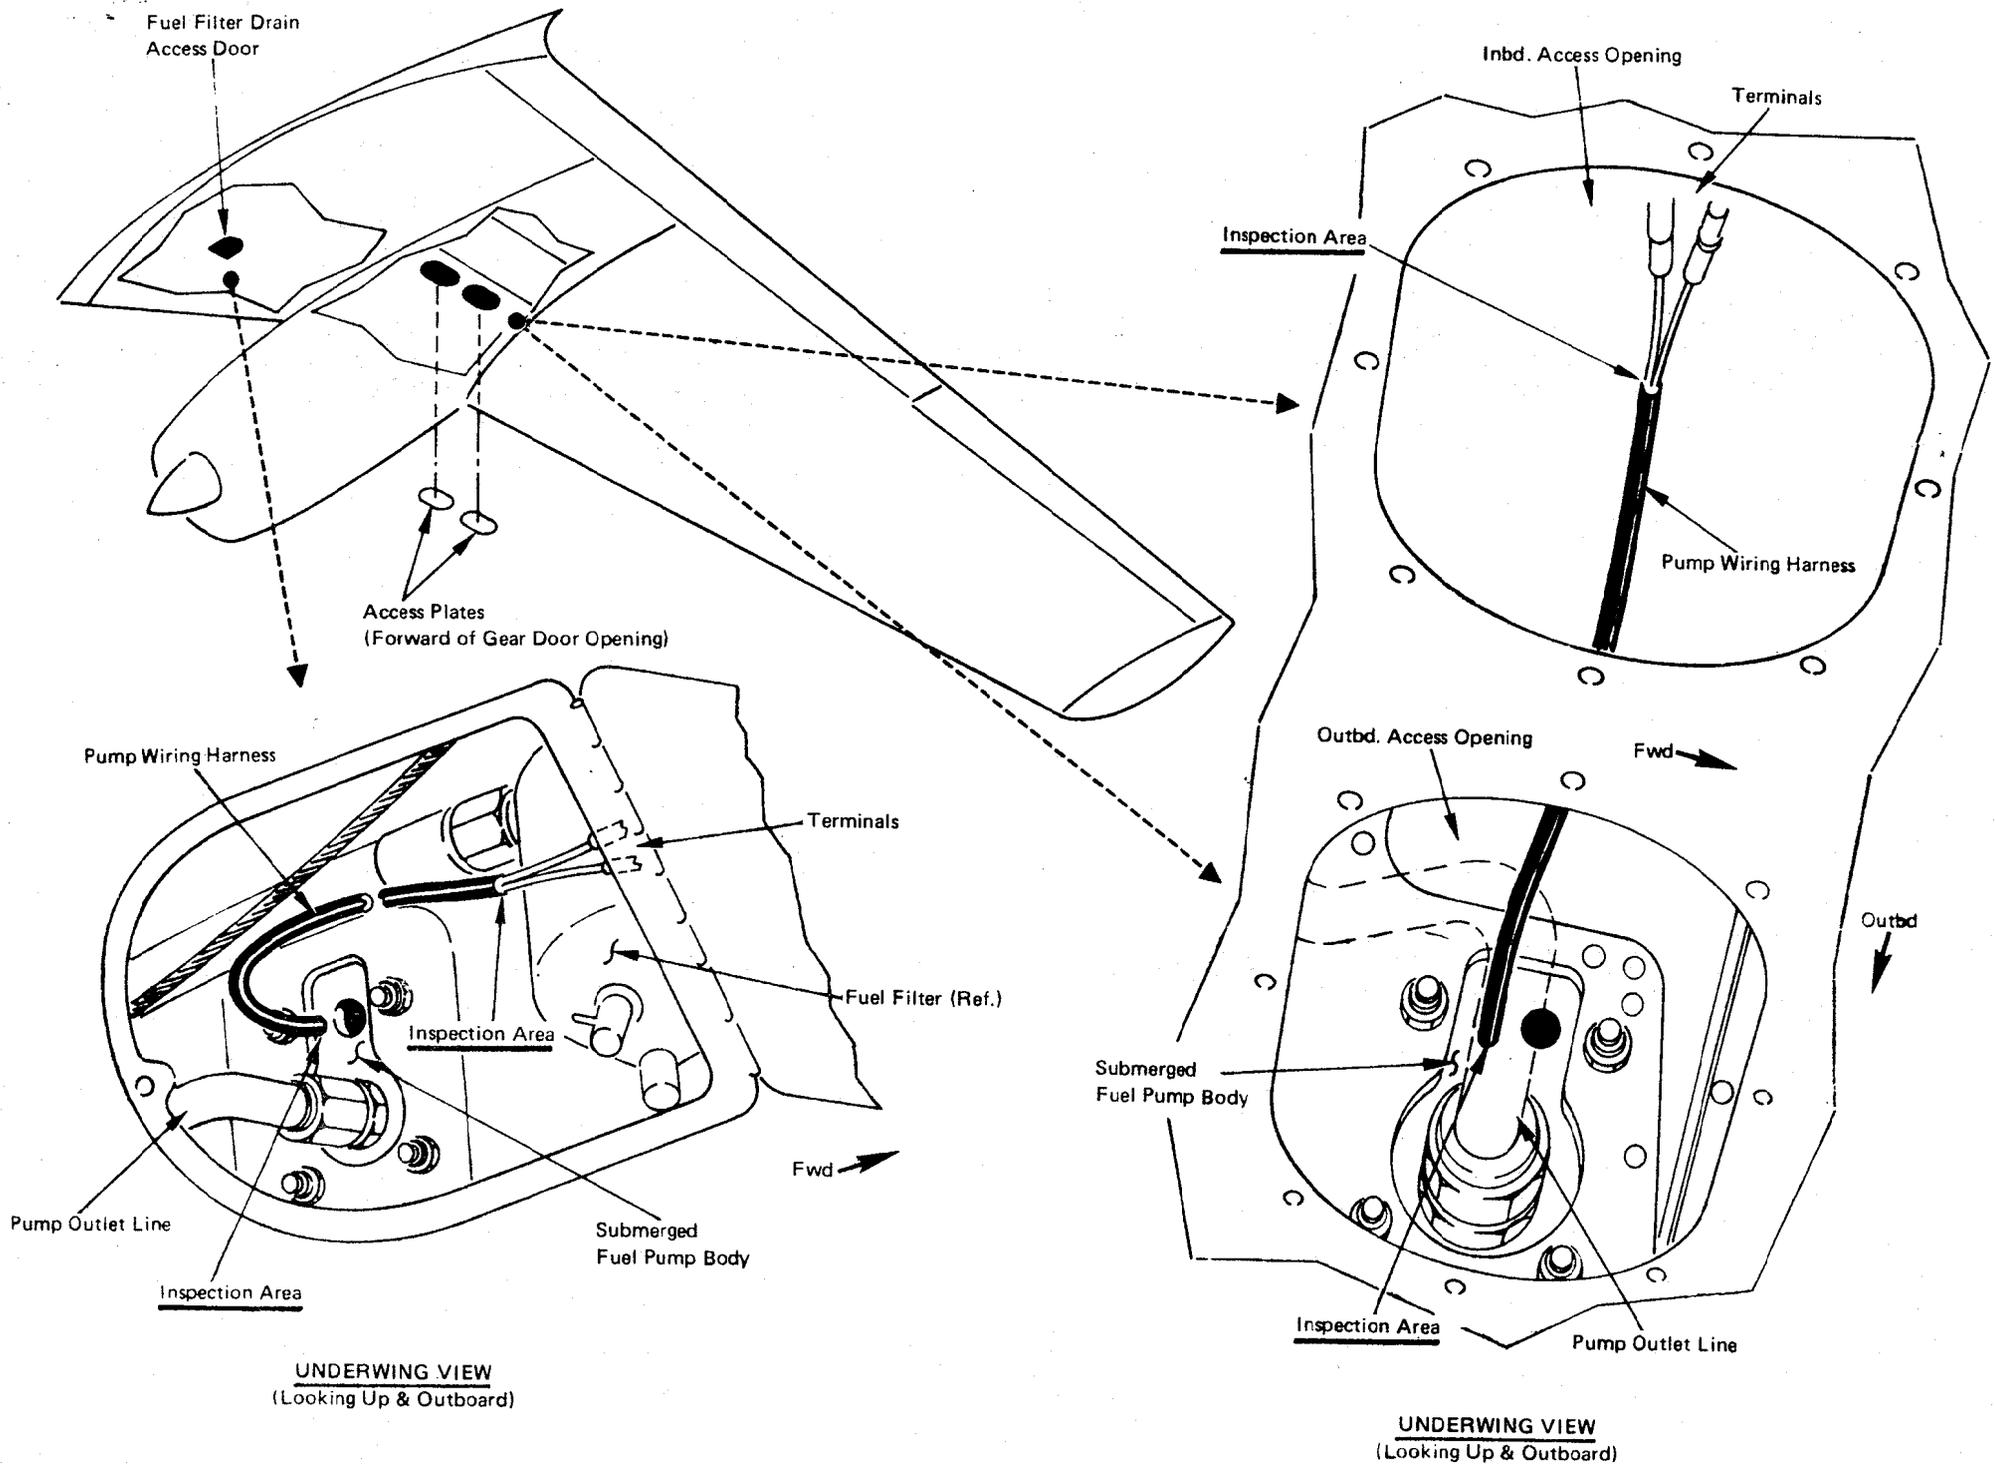
Instructions: Refer to attached sketch/instruction sheet for an illustration of (1) submerged fuel pump location (four per aircraft) and (2) areas to be inspected for evidence of leakage.

NOTE: The most positive means of detecting fuel leakage through the submerged fuel pump wiring harness is to check (with the pump operating) the wiring harnesses where the protective sheet terminates, since any fuel escaping through the wiring harness would be under pressure, and the leakage would be evident. The attached sketch illustrates this area in detail.

1. Gain access to submerged fuel pump wiring harness terminals.
2. Check adjacent structures for evidence of leakage (i.e., fuel stains).

4. If above described fuel leakage is apparent, replace applicable submerged fuel pump (see Material Required, below).
5. Make appropriate log book entry .

Submerged Fuel Pump(s), Piper Part No. 48812-00 (maximum number per aircraft, four each), if required, per the subject inspection.
